MEMORANDUM

**Re: Pre Acquisition Building Condition Report for
Moorecroft Camp Property
1563 Stewart Rd. Nanoose District
Lot A, DL 110, Plan 1777**

MOORECROFT CAMP
PRE ACQUISITION BUILDINGS CONDITION REPORT 2010

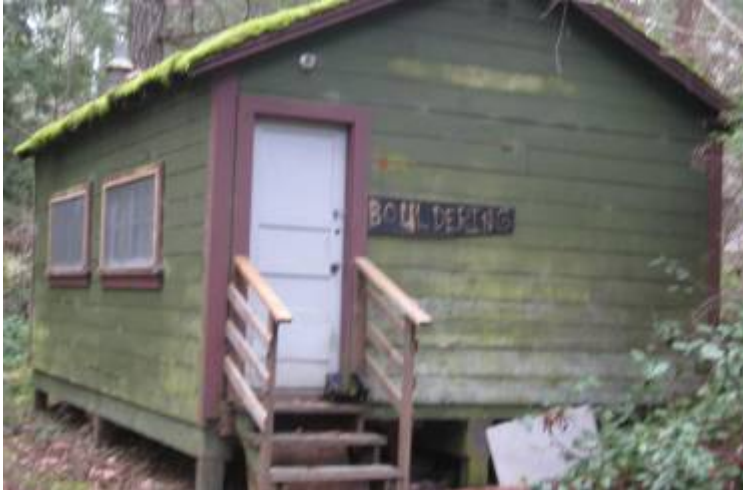
Building Name: Bouldering Cabin

- Older building in poor overall condition and functionally obsolete.
- Insect damage is evident in areas of support structure.
- Building cladding and roof in poor condition.

Major Asset Maintenance / Capital Improvement Requirements: Recommend removal from service. Estimated removal cost \$3k

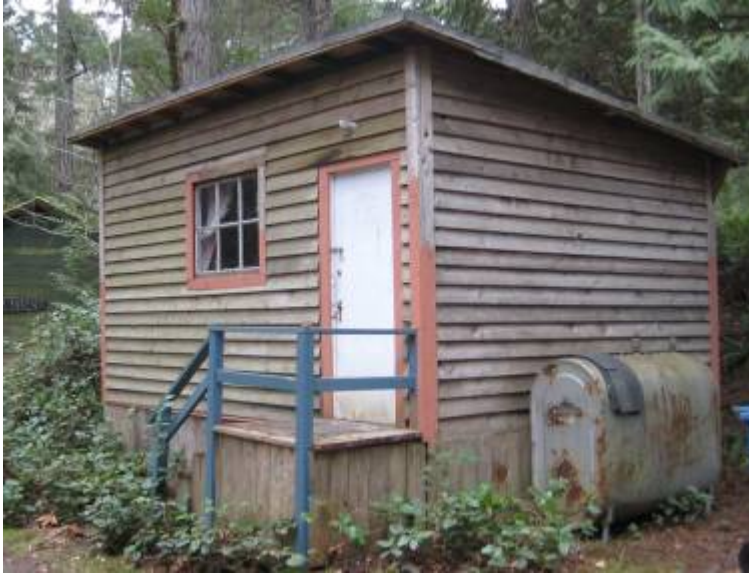
Building Name: Fern Cottage

Building Condition Summary: Older building in poor overall condition.

- May not be suitable for current use.
- Insect damage evident in exposed structure.
- Roof is in poor condition and lacks proper ventilation.
- Wooden access stairs are in poor and potentially dangerous condition.

Major Asset Maintenance / Capital Improvement Requirements: Recommend removal from service. Estimated removal cost \$3k

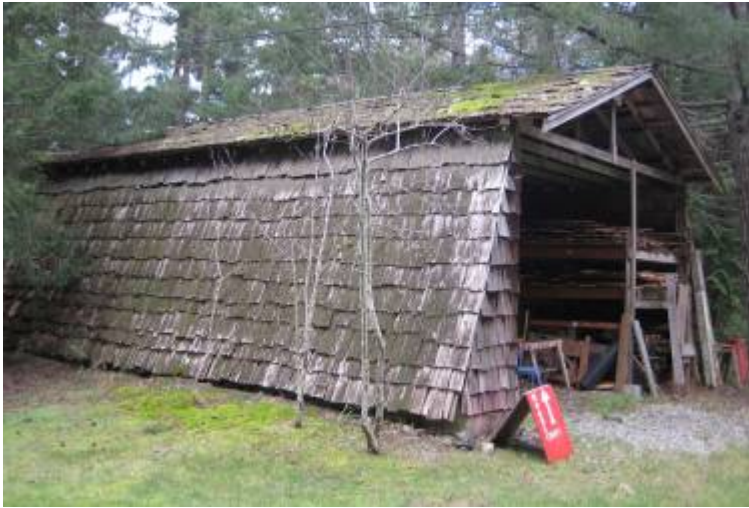
Building Name: Wood Shed / Maintenance Building

Building Condition Summary: Appears structurally adequate by initial observation, but roofing/siding require replacement.
 Ok for present use.

Estimated major asset maintenance expenses for years 1 – 5 are \$6k order of magnitude.

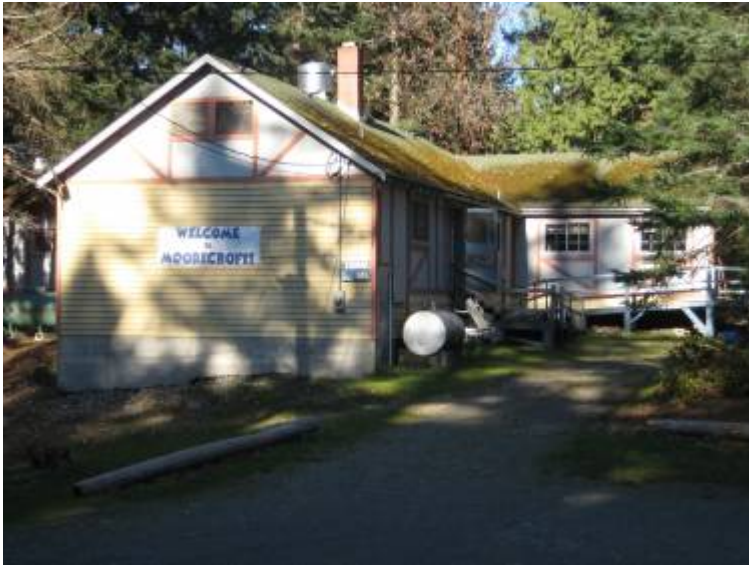
Building Name: Stringer Hall

This building appears in fair overall condition, however major asset maintenance is required to:

The building was partially resided about 2002, however the back of the building was not sided at the time as some degree of deterioration was discovered that would require additional repairs. The rear fire-exit doors lead to an elevated wooden deck with wooden stairs leading to the ground. This deck and stairs are in poor condition and exhibit wood decay and deterioration. Replacement is required. Wood decay from the deck may have spread into the building, further investigation is required to confirm.

The existing asphalt shingle roof is approx 14 years old with a remaining service life of approx 5 years. Roofing replacement along with any subsequently discovered roof deficiencies should be planned for 2016.

Exterior wooden access ramps, stairs, landings, and porch roof structures are generally in poor and deteriorated overall condition. This presents a potential safety hazard and a replacement plan would be advised within several years.

Estimated major asset maintenance expenses for years 1 – 5 are \$30k order of magnitude.

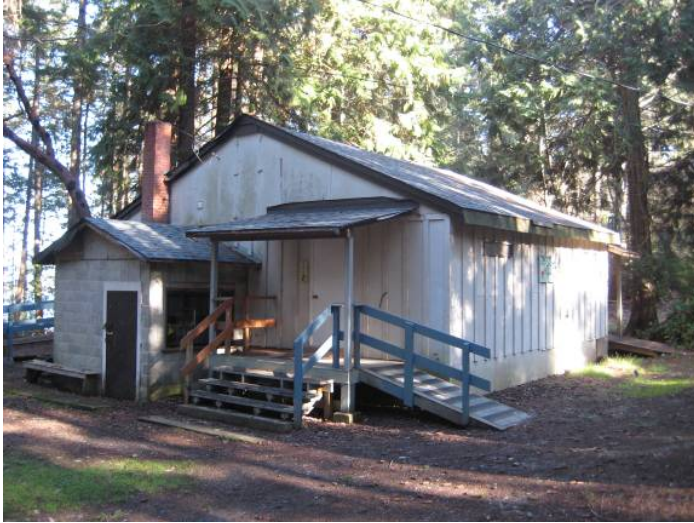
Building Name: Splash 1 Washroom Building

The overall condition of this building is considered poor.

Access stairs, ramps and landings are in poor condition and should be repaired or replaced in the near future.

There is an obvious structural sag in the roof deck and minor sagging was noted in one of the interior washroom ceilings.

There is no mechanical exhaust ventilation provided and the plywood interior indicates signs of moisture damage and mould.

Building could continue to provide some use for the short term, but replacement or removal from service is recommended.

Estimated removal costs \$10k w/o ACM or environmental remediation's.

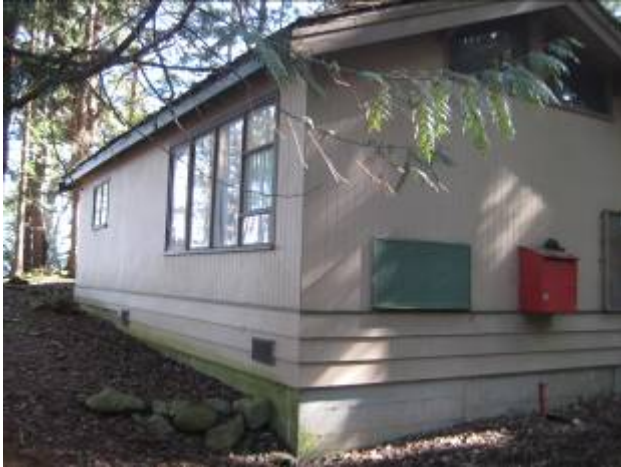
Building Name: Directors Residence

Building Condition Summary: Fair overall condition.

- Roof is in poor condition and leaks. Replacement roof covering required.
- Roof deck and trim show evidence of some moisture and rot damage, repair required.
- Siding in fair and serviceable condition but should have additional clearance from the ground in some areas.
- Windows are in poor condition.
- Original oil-fired space heater was previously removed and heating is presently provided by using plug-in portable electric heaters only.
- Interior condition - Fair

Building is serviceable with required repairs. Installation of a propane gas-fired space heater should be considered. Estimated major asset maintenance expenses for years 1 – 5 are \$7k order of magnitude.

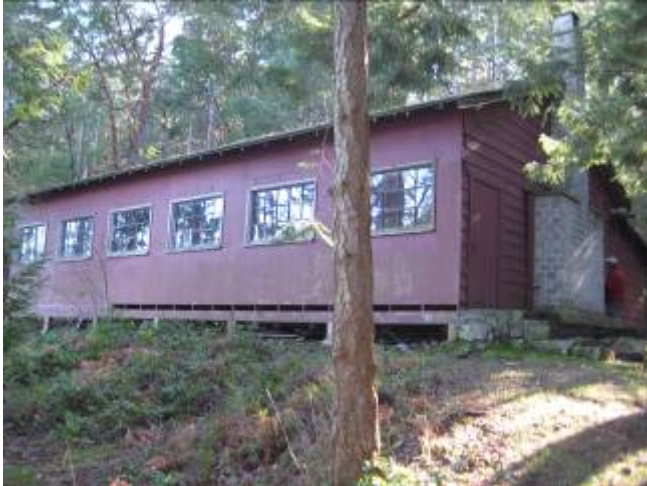
Building Name: Kennedy Lodge

On first observation the building appears in fair condition, however inspection of the wooden foundation system indicates structural component distress, with compression/tilt and insect damage all noted. Additional inspection and/or building intrusive investigation would be required to confirm the extent of the foundation problems. Structural repairs will be necessary to correct existing conditions.

These roofing products typically have a very long service life but often require a roof and building structure capable of supporting the additional weight load imposed by the product. Additional investigation is required to confirm the structural condition of the building.

- Structural repairs
- Upgrades and improvements to fire protection, occupant safety and accessibility
- Replacement of inefficient oil-fired heating system.

Estimated major asset maintenance expenses for years 1 – 5 are \$10k order of magnitude.

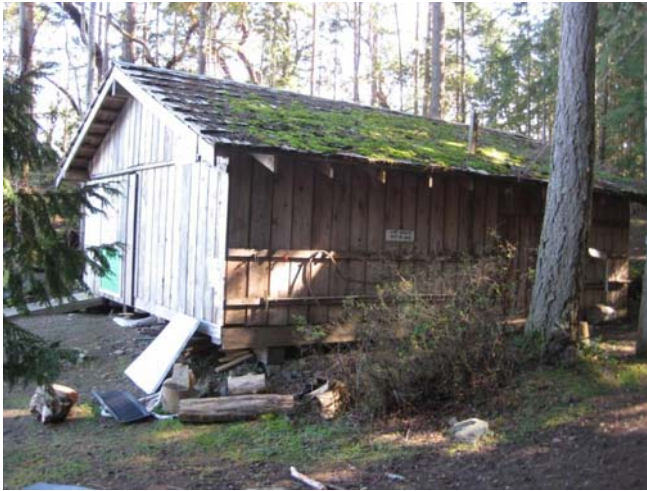
Building Name: Boat House

- Building construction is unconventional, no obvious signs of distress or failure where noted.
- Roof replacement will be required within several years.

Fire & Safety: At the time of construction this building may have required Building Permits and Approvals. No records could be found to support the issuance of any Building Permits or the benefit of inspection. Safety upgrades should include the installation of emergency lights and a portable fire extinguisher.

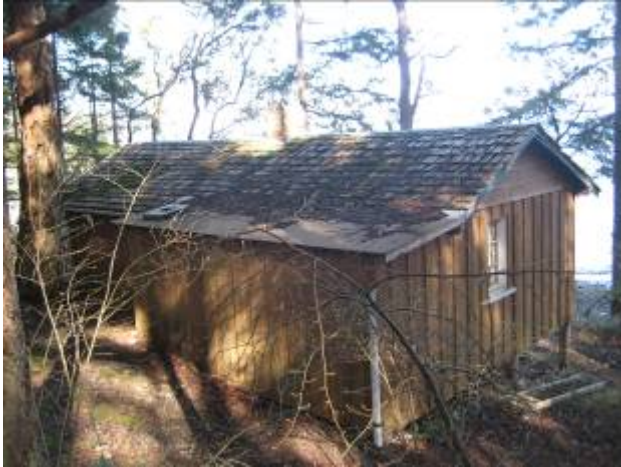
Building Name: Miss Moore's Cabin

- Cabin is considered to be in fair overall condition.
- Roof deck shows some structural sag and there is inadequate roof ventilation.
- New roof covering is required.
- Siding ok.
- Stairs and ramps ok.

Building requires new roof cover and may require some structural repairs. With regular maintenance cabin could continue to provide service. Estimated major asset maintenance expenses for years 1 – 5 are \$5k order of magnitude.

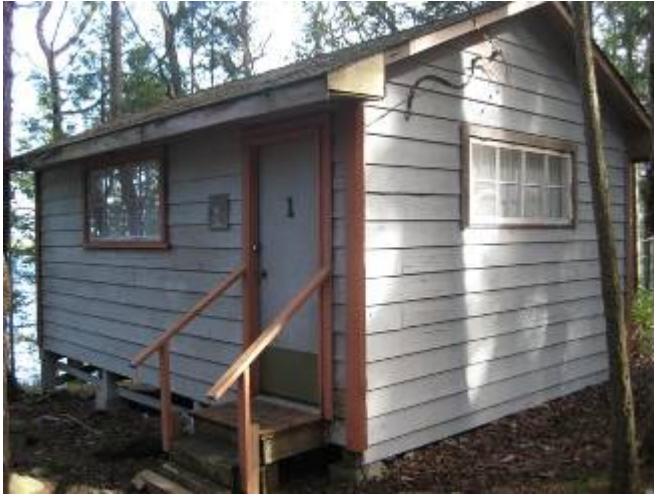
Building Name: Cabin #1

Building Condition Summary: Overall condition “fair”

- Insect damage observed in exposed structural components.
- New stairs and landing required.

Estimated major asset maintenance expenses for years 1 – 5 are \$2k order of magnitude.

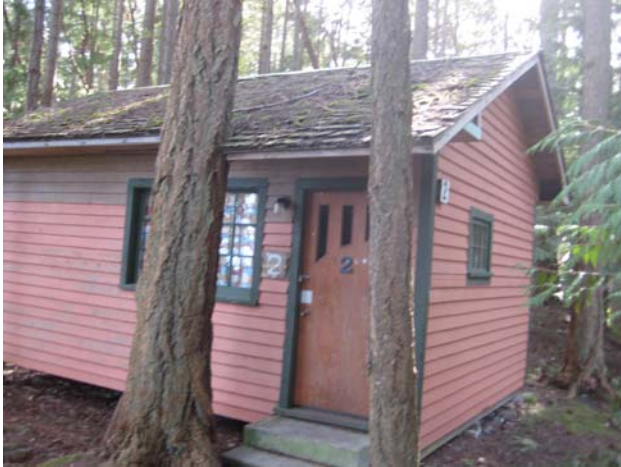
Building Name: Cabin #2

Building Condition Summary: Fair condition

- Foundation structure in poor condition, repairs required.
- Insect damage is evident in structural components, siding and fascia boards.
- Siding in fair overall condition.
- Roof in poor condition and requires replacement.

Repairs required for continued service.

Estimated major asset maintenance expenses for years 1 – 5 are \$4k order of magnitude.

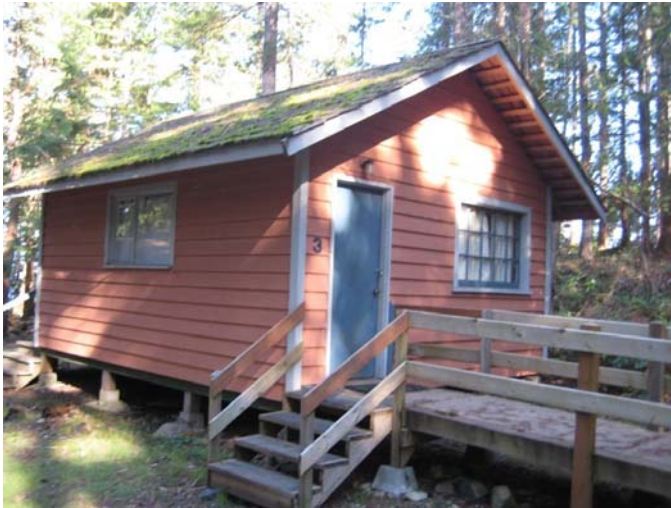
Building Name: Cabin #3

- Exterior of building appears in good order.
- Roof requires repairs or new roof cover.
- Rear access ramp has soft spots.

Building will continue to function with repair and routine maintenance.
 Estimated major asset maintenance expenses for years 1 – 5 are \$3k order of magnitude.

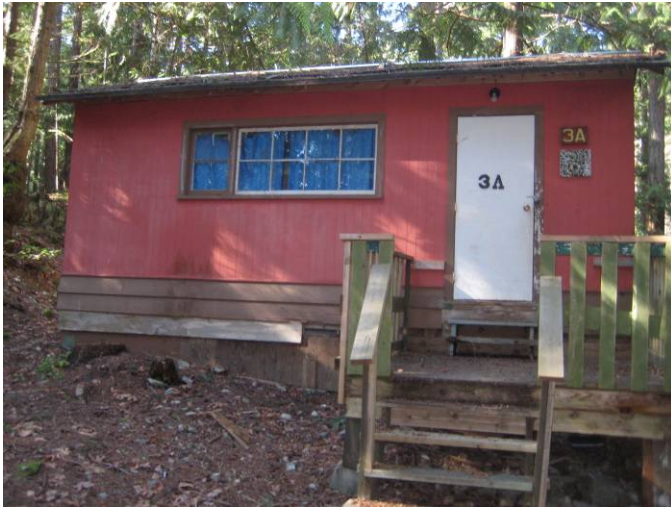
Building Name: Cabin #3A

- Older building considered in poor overall condition.
- Cladding in fair condition.
- Skirting in poor condition.
- Stairs / Landing in poor condition.

Estimated removal costs \$3k

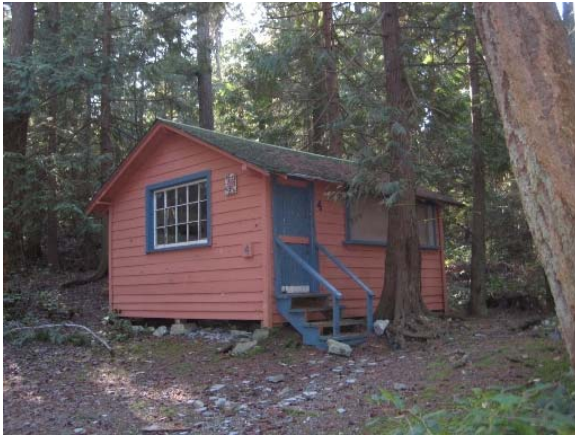
Building Name: Cabin #4

- Older building in fair condition.
- New roof required.
- Cladding in fair condition.
- Some insect damage observed in floor structure.
- New stairs and landings required.

Building is nearing the end of its service life.
 Estimated removal cost \$2k

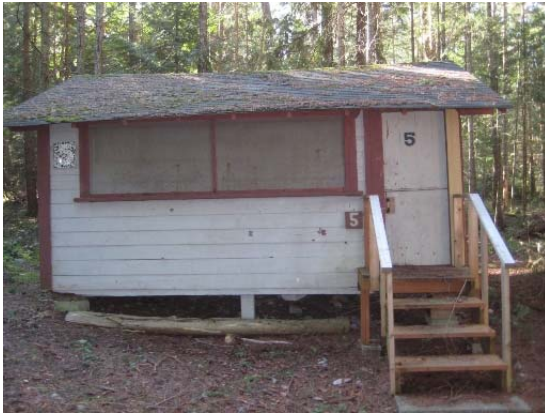
Building Name: Cabin #5

- Older building in poor overall condition.
- Decay in structural supports.
- Considerable roof sag and under supported roof structure.
- Poor structural condition.

Recommend removal from service.

Estimated removal cost \$2k

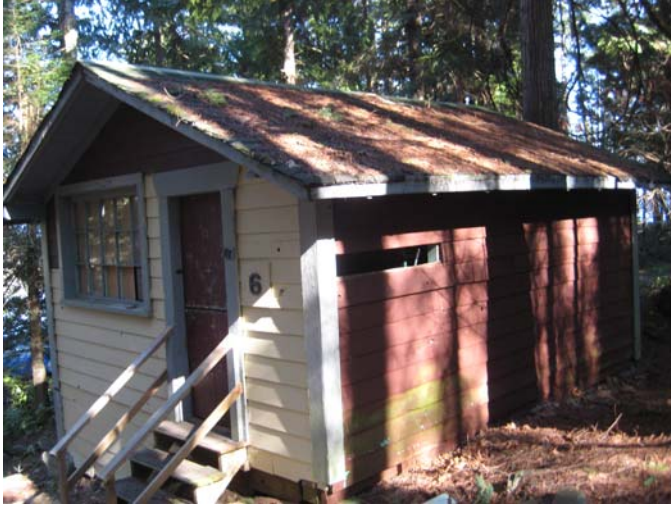
Building Name: Cabin #6

- Older building in poor overall condition.
- Roof sag noted.
- New roof covering required.
- Cladding in poor condition.
- Deterioration noted in support structure (compression).

Recommend removal from service.

Estimated removal cost \$2k

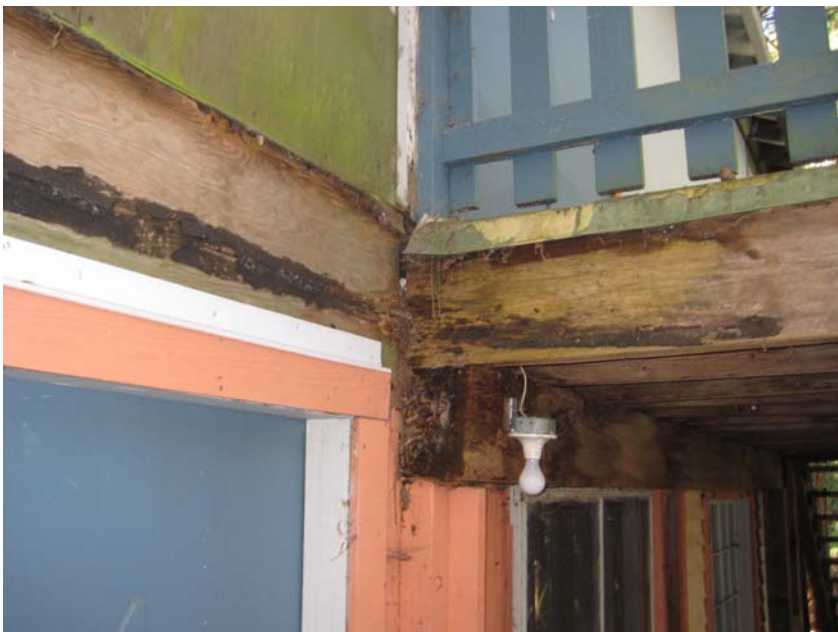
Structural deterioration of balcony and siding at Stringer Hall

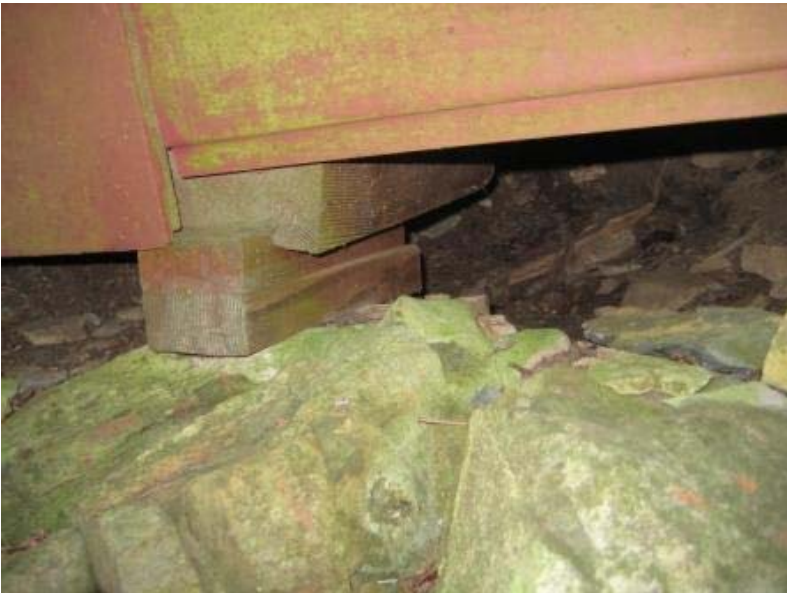
Structural condition at Kennedy Lodge.
Many of the wooden structural components of this building show evidence of Powder post beetle infestation and the resulting damage.

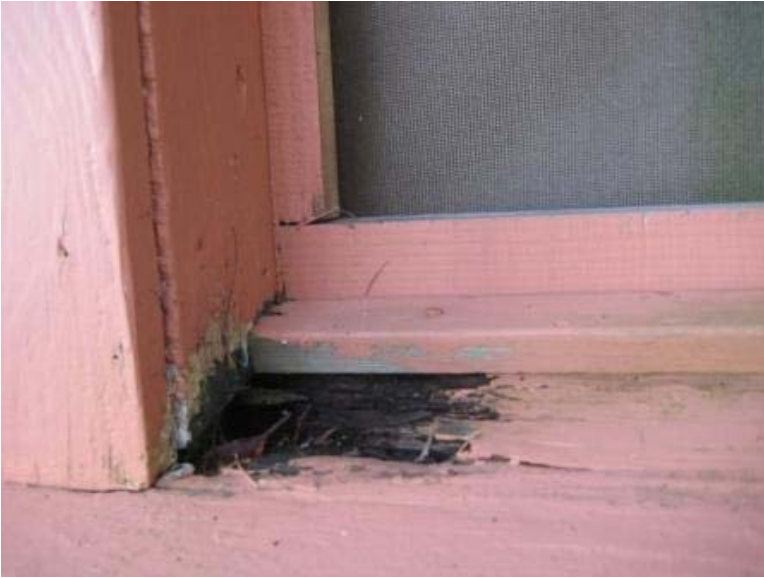
Rot and decay are evident in many parts of the older cabins.
Shown in windowsill here.

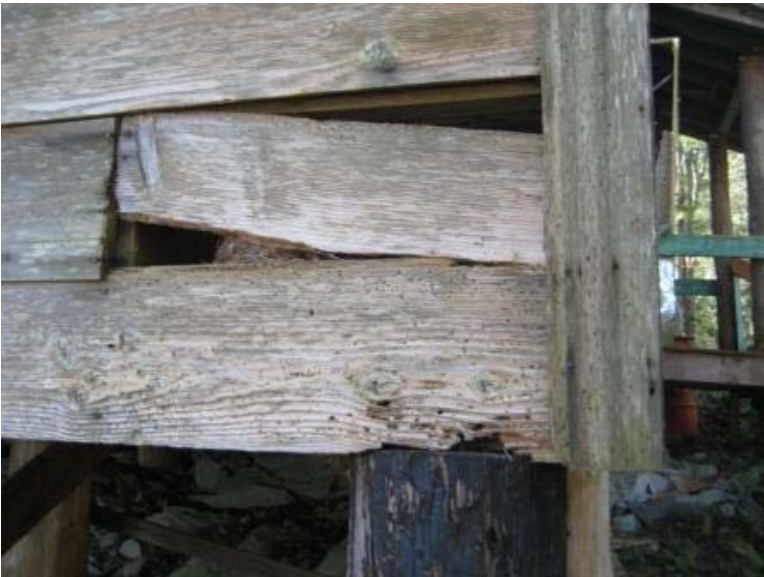
Severe structural deterioration shown in Craft Hut Building
