REGIONAL DISTRICT OF NANAIMO

2954 Trans-Canada Highway, Nanaimo, BC Pre-Demolition Asbestos Survey

Pre-Demolition Asbestos Survey

2954 Trans-Canada Highway, Nanaimo, BC

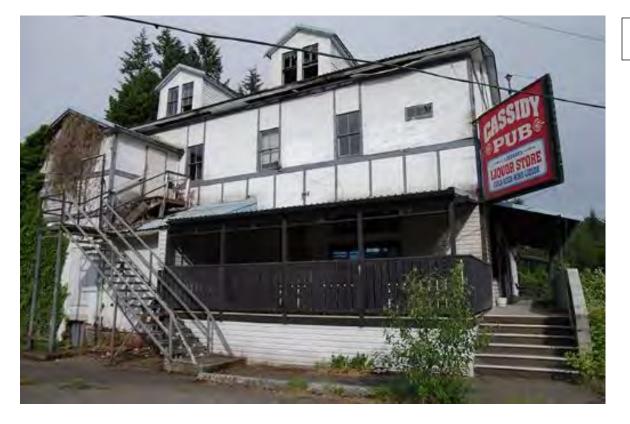
Before Fire Damage

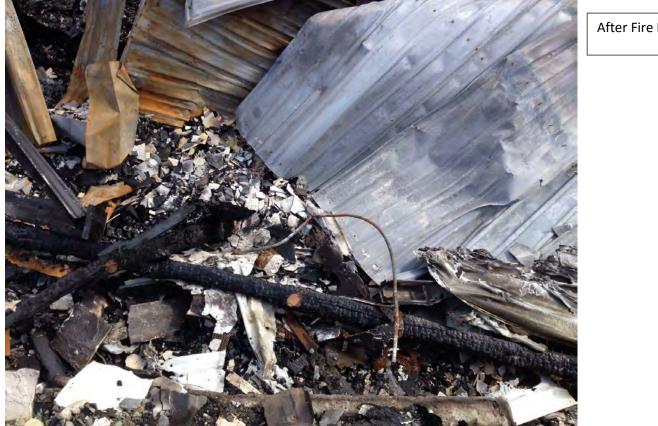
After Fire Damage
