Annie Creek Habitat Overview Survey

Regional District of Nanaimo

D.R Clough Consulting

July 2017

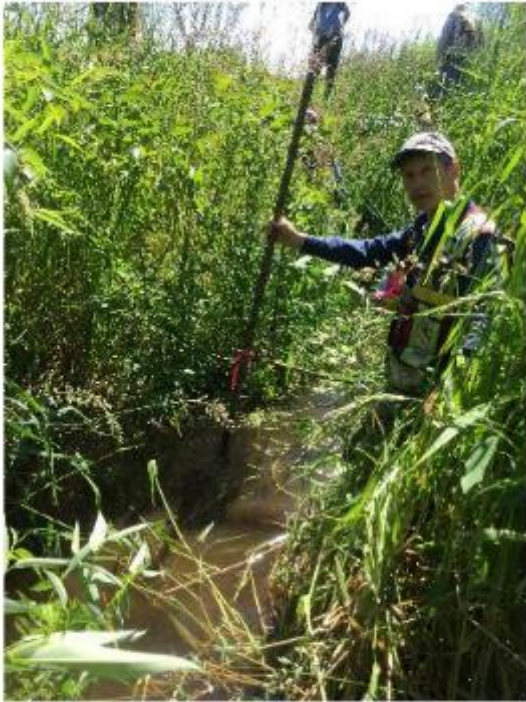
The riparian community around Reach 1 of Annie Creek scored fair (Table 3). The plant community in lower Reach 1 is significantly limited by historic and ongoing residential encroachment. We found the lower survey riparian depth was only 3-5 m. A visual inspection indicated the upper half of the reach to the highway had a better riparian canopy. The newer upper areas appear to have a bylaw designated treed setback of 15-30 m past the lawns. The riparian canopy consists of Red Cedar (*Thuja plicata*), Douglas Fir (*Pseudotsuga menziesei*) and Broadleaf Maple Trees (*Acer macrophyllum*). The issues of depth of riparian vegetation can be easily addressed by planting. Future planting plans should include removal of invasives such as Reed Canary Grass (*Phalaris arundinacea*) and Yellow Flag Iris that is choking out other plant emergence.

Photo 1) Invasive Reed Canary Grass choking creek at R1, Pool 2

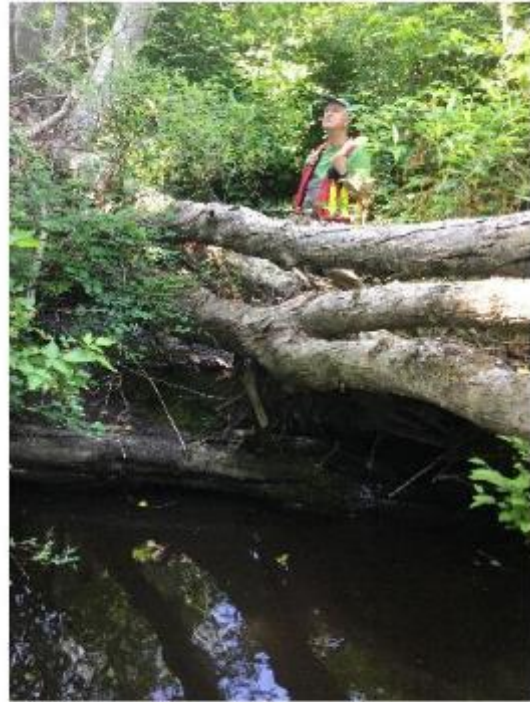
Photo 2) Woody debris jam upstream of Reach 1, Pool 5

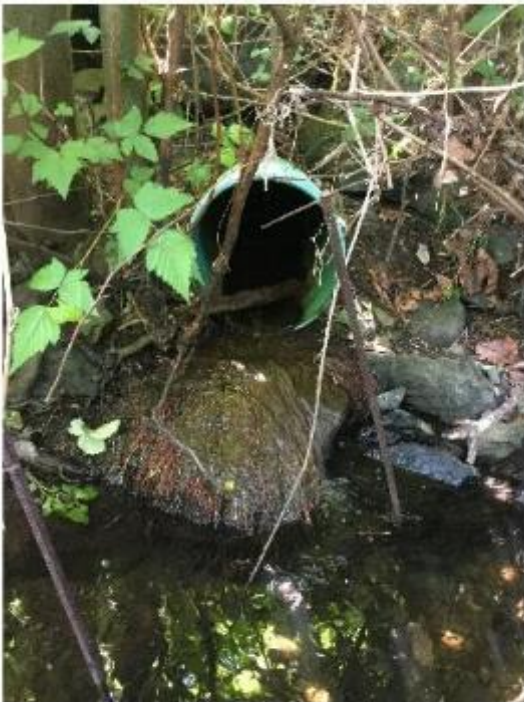
The channel in the lower reach (i.e. Pool 4) has been altered by the installation of rip rap wall on the right bank and further upstream are more placed blast rocks that have fallen into the channel. We found a blue plastic pipe that discharges water into the creek. The rocks adjacent to this pipe were coated with algae, indicating that the water potentially carries excess nutrients (phosphates and nitrates) and should not be directed into the creek. There is also a small debris jam in the lower reach that obstructs the creek flow and potentially impairs juvenile fish passage. The woody materials here are small enough that this issue can be resolved by removing the wood by hand.

Photo 3) Reach 1, Pool 5 right bank storm pipe outlet

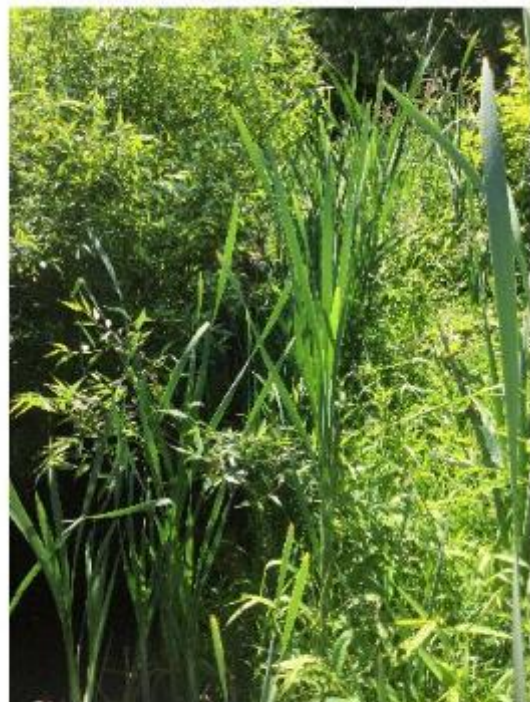
Photo 4) Invasive Yellow Flag Iris along Reach 1

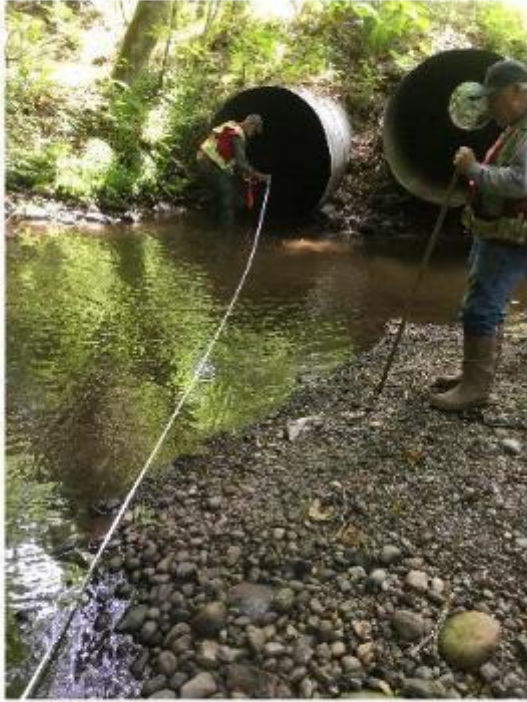
Annie Creek passes under Bradshaw Road through two 1.8m diameter and 21m long corrugated metal pipes (CMPs). These culverts appear undersized and are degrading. We observed that water can leak under the culverts and saturate adjacent bank materials. The right bank culvert is hung by approximately 50cm and the left bank culvert is not embedded into the creek bed. The pipes appear to be undersized based on the backwatering effect on them as well as the erosion on the right bank below the pipes. As this is a fish-bearing stream both culverts need to be sufficiently embedded into the creek substrates as to not impair the quality of fish spawning habitat. Not only are these culverts one of the largest factors impeding fish habitat within Annie Creek but also have the potential to negatively influence the structural stability of the Bradshaw Road crossing.

Photo 1) Reach 2, Bradshaw Road culverts hung and rotten

In Table 9 below are a list of restoration activities that were determined from the survey data and observations. We noticed the Annie Creek watershed has some significant attributes as well as some handicaps. The Erosion at Bradshaw Road is caused by the poorly placed and sized culverts. Replacing these pipes would be a significant improvement. The riparian reserve area of Crown Land above Bradshaw is significant. The impacts of upland farming and historic logging still result in many dry areas in this reach in summer. Controlling sediment from Grovehill Road and ditches would stop an impact that has been ongoing for years. The lower reaches of Annie Creek have water but they are infilled by these sediments. More trees need planting in Reach 1 which has a possible bylaw protected area where restoration access and permission will be easy. Addressing the pipe effluent into the creek at Reach 1 is also important as there are pollutants.

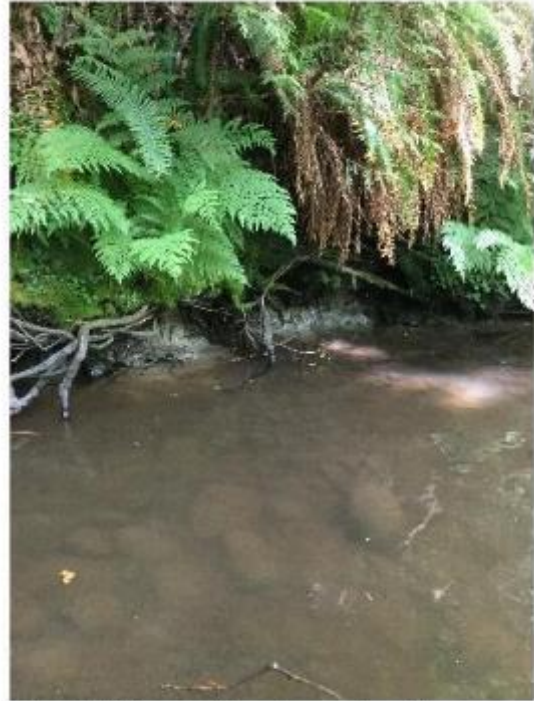
The eroded banks have undercut large Maple trees below Bradshaw Road. These trees are important riparian cover and help to condition the creek water temperature. They are going to fall into the creek and would deposit additional sediments downstream and potentially impair water flow.

Photo 2) Reach 2 bank erosion site

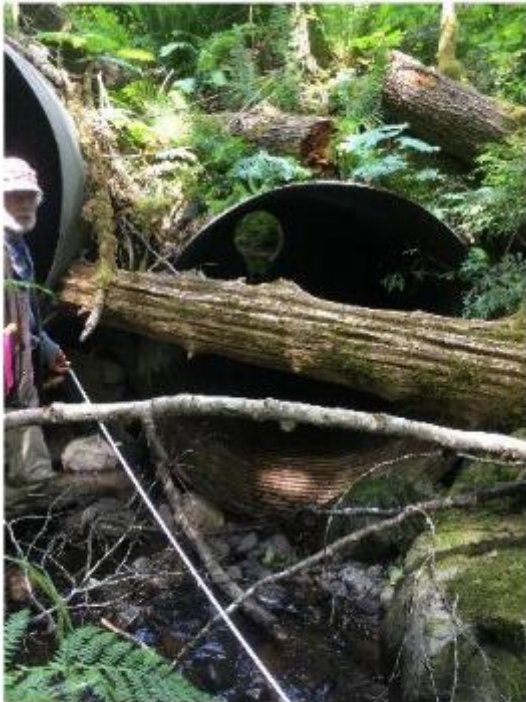
Photo 3) Bradshaw culvert impairing fish passage and hydrology

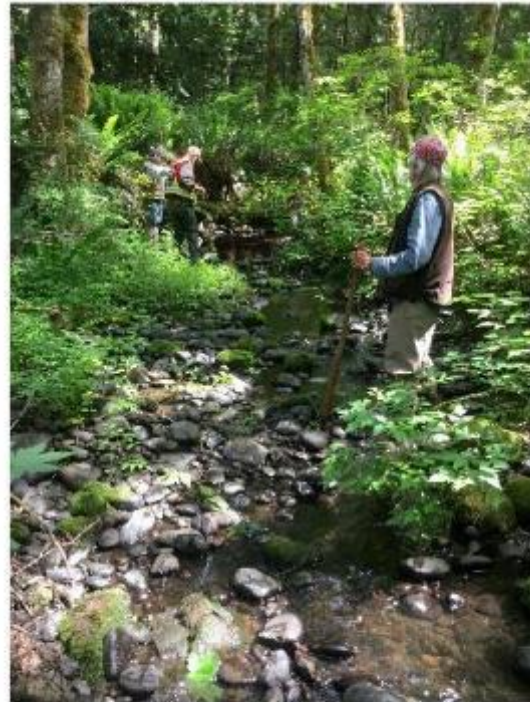
Photo 4) Reach 2, Riffle 4 too long, bound to dry in summer

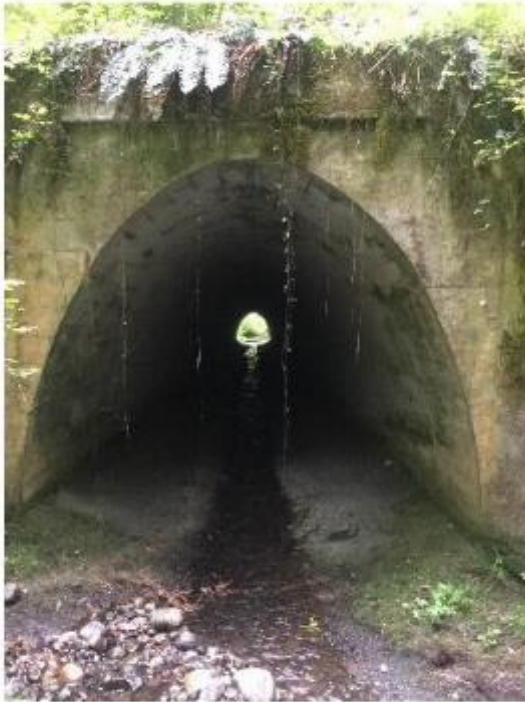
Photo 1) Reach 3 cement culvert under railway track

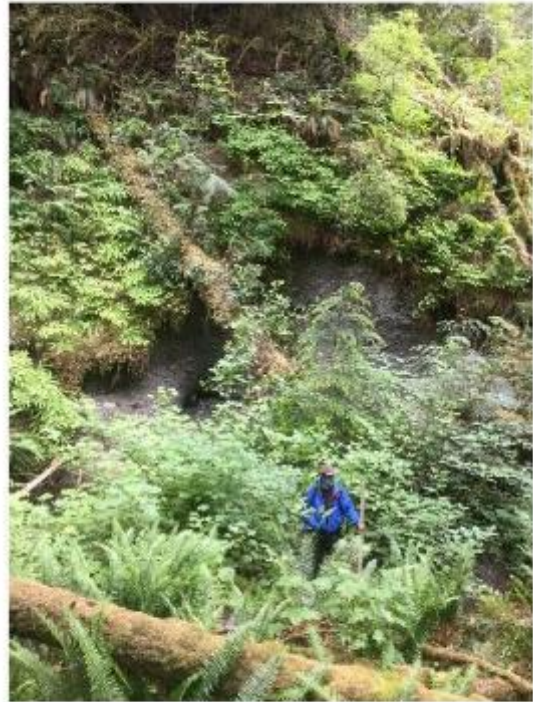
Photo 2) Sloughing bank and sediment source at Annie/Fletcher confluence

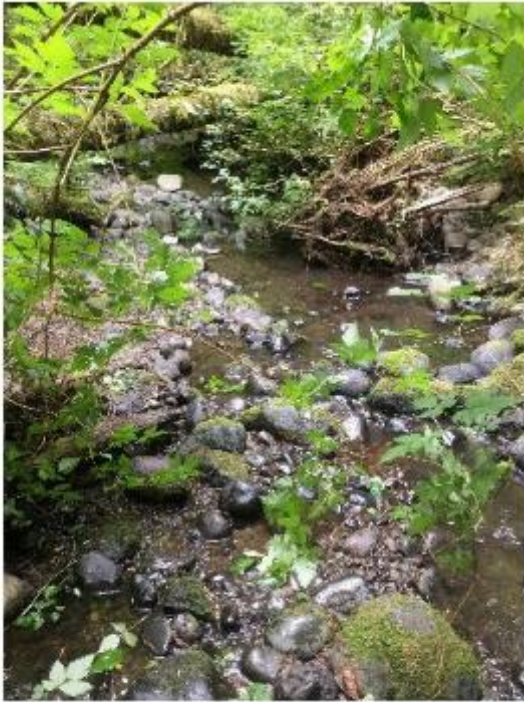
Photo 3) Reach 3, Riffle 5 is way too long and impairs fish passage

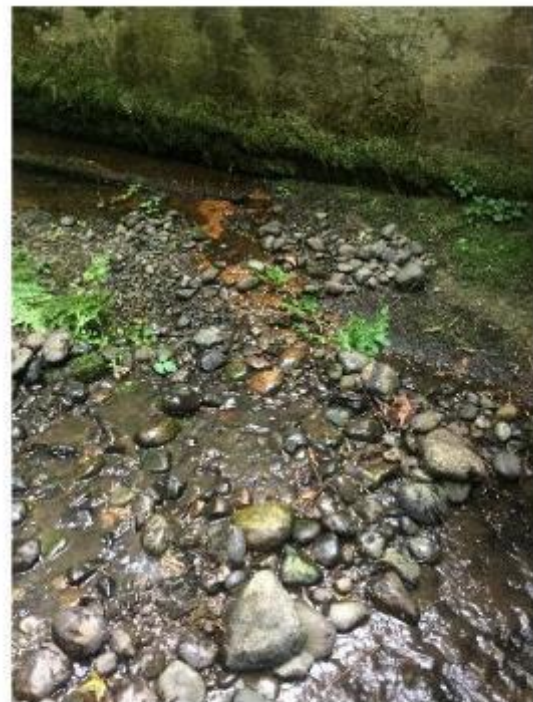
Around the mouth there is orange residue from iron leaching out from the culvert footings. Water quality at this station was normal and iron residue is likely the result of buried railway or forestry equipment. Monitoring water quality or working instream within Reach 3 would be difficult as access is a steep and narrow footpath.

Photo 4) Railway culvert leaching iron residue into creek
