REGIONAL DISTRICT OF NANAIMO

Water Service Area Annual Report 2015

Decourcey Water System

June 2016

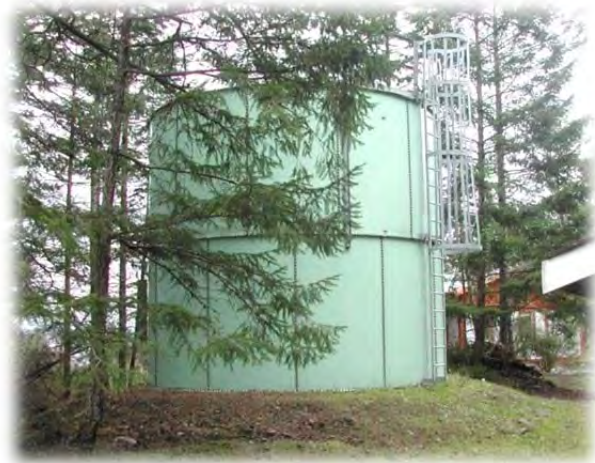
One steel above-ground reservoir is present at 3280 Bissel Road, and has a capacity of 136 m³ (30,000 imperial gallons).

Decourcey Water Storage Reservoir

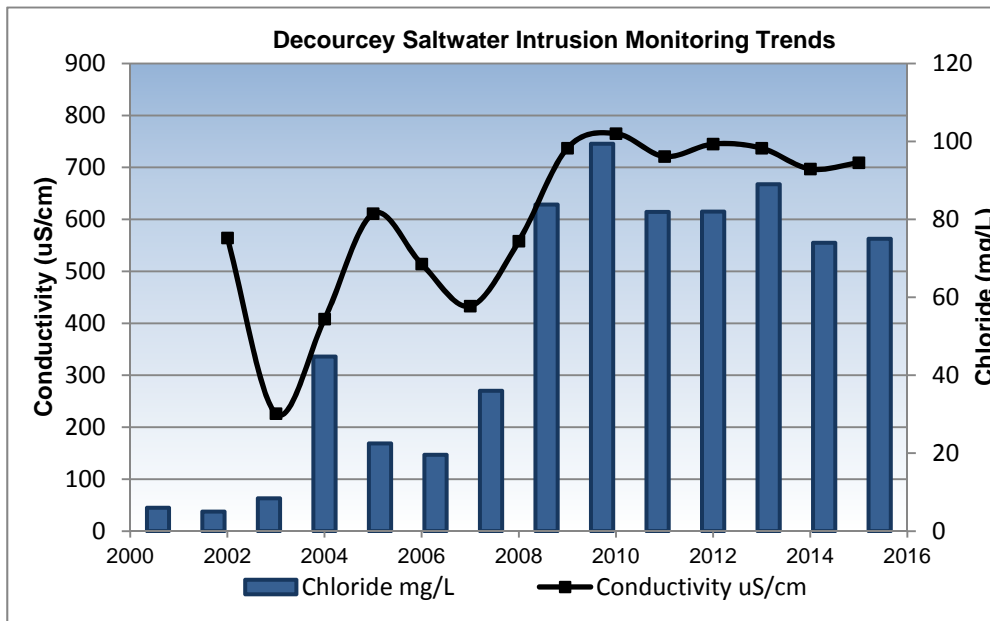
The Conductivity and Chloride levels in the Decourcey well water had an increasing trend from the year 2000 to 2010, but appear to have stabilized since 2010.

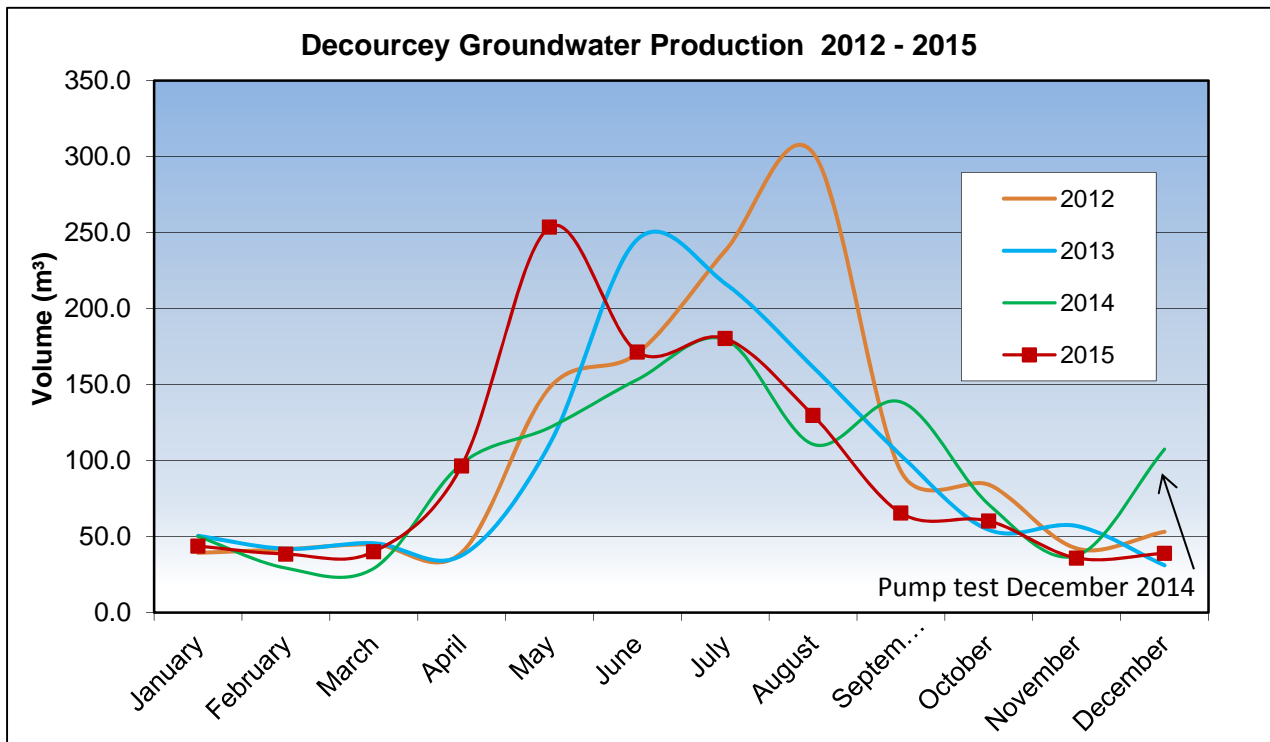
The monthly groundwater production in the Decourcey system for the past 4 years is shown in the chart below. Groundwater production in 2015 was similar to or lower than previous years, except a period of higher than normal use during April and May. This increase may be attributed to unseasonably warm spring temperatures and less than average precipitation, which resulted in an early start to the watering season.

In the Fall/Winter of 2015, the average usage per home in Decourcey was 0.32 cubic metres per day (70 imperial gallons). In the summer, the average water usage was 1.17 cubic metres per day (257 imperial gallons). Based on these figures, the annual consumption per capita is estimated to be 264 L/day (based on 2.3 people/household). This consumption is 4% less than the RDN system average of 274 L/day/capita for 2015.
