# REGIONAL DISTRICT OF NANAIMO

## Water Service Area Annual Report 2015

## Melrose Terrace Water System

June 2016

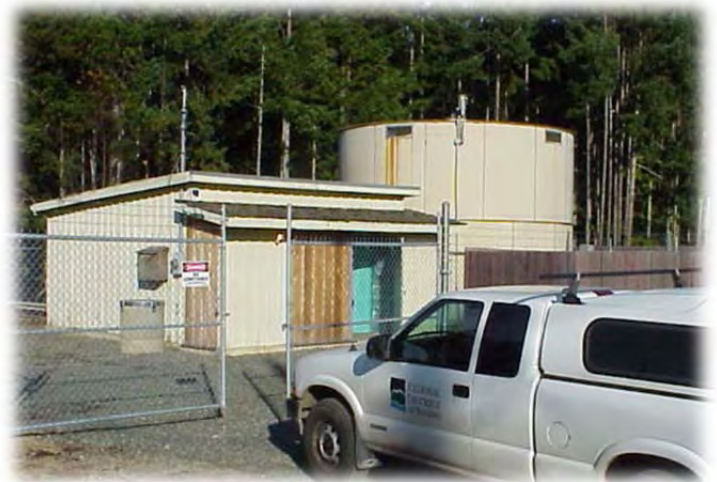
One service reservoir (steel structure) is present at 3853 Melrose Road, and has a capacity of 136 m<sup>3</sup> (30,000 imperial gallons).

**Melrose Pumphouse and Reservoir**

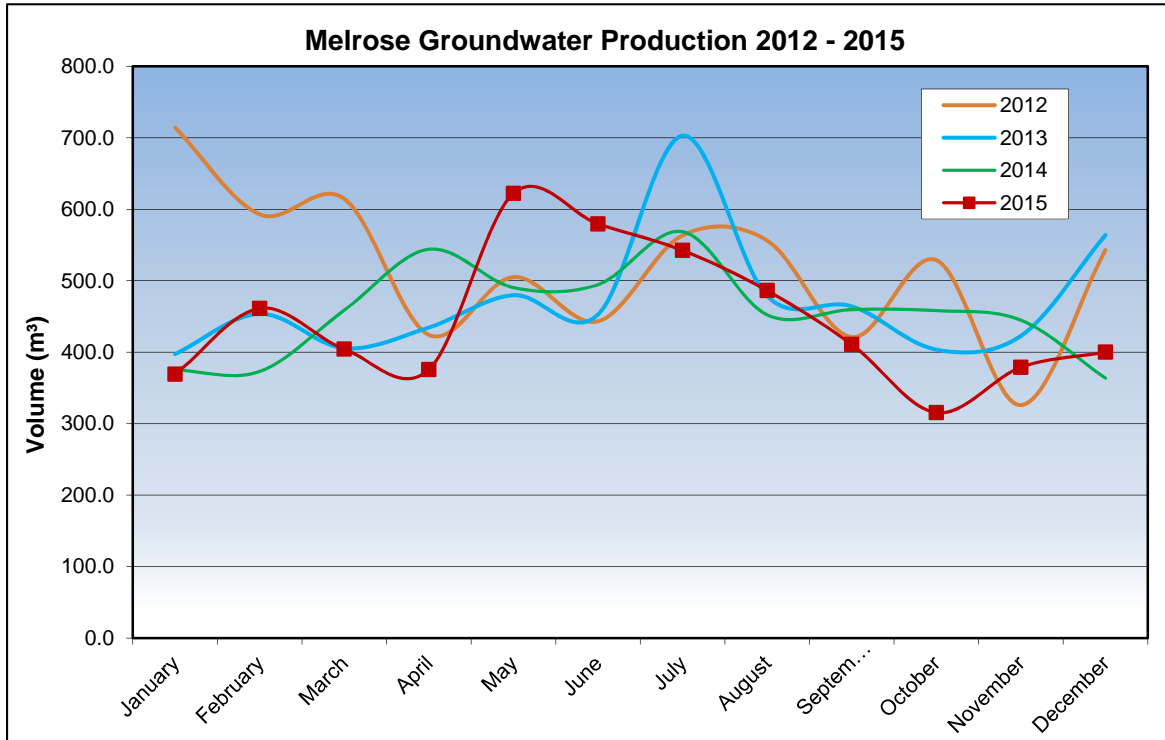
The monthly groundwater production in the Melrose system for the past 4 years is shown in the chart below. Groundwater production in 2015 was similar to or lower than previous years, with the exception of an earlier than normal peak in April - May.

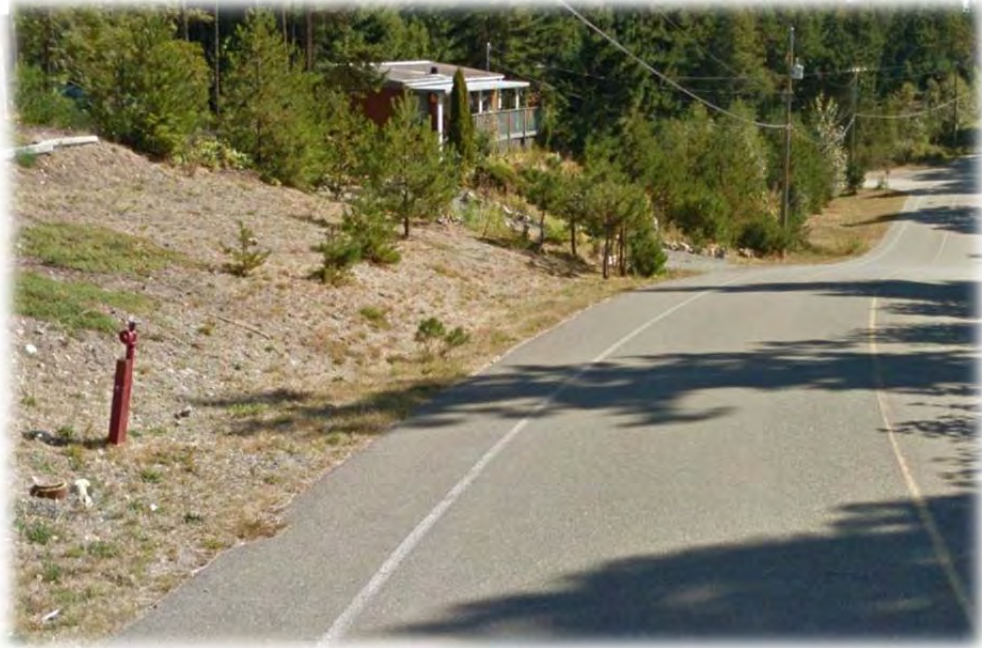
Appendix A - Map of Melrose Water Service Area

The Melrose Water Service Area was established in April 2005 when the RDN acquired the existing Melrose Terrace Strata Plan VIS3747 water system. The water service area is comprised of 28 residential properties on Melrose Road located near the Alberni Highway, southwest of Coombs. The water source for the Melrose Water Service Area comes from one groundwater well located nearby. The water is chlorinated and stored in a single reservoir. The water is then filtered through sand and charcoal filters before entering the distribution system. A portable generator is available in the event of a power outage. A map of the Melrose Water Service Area is provided in Appendix A for reference.

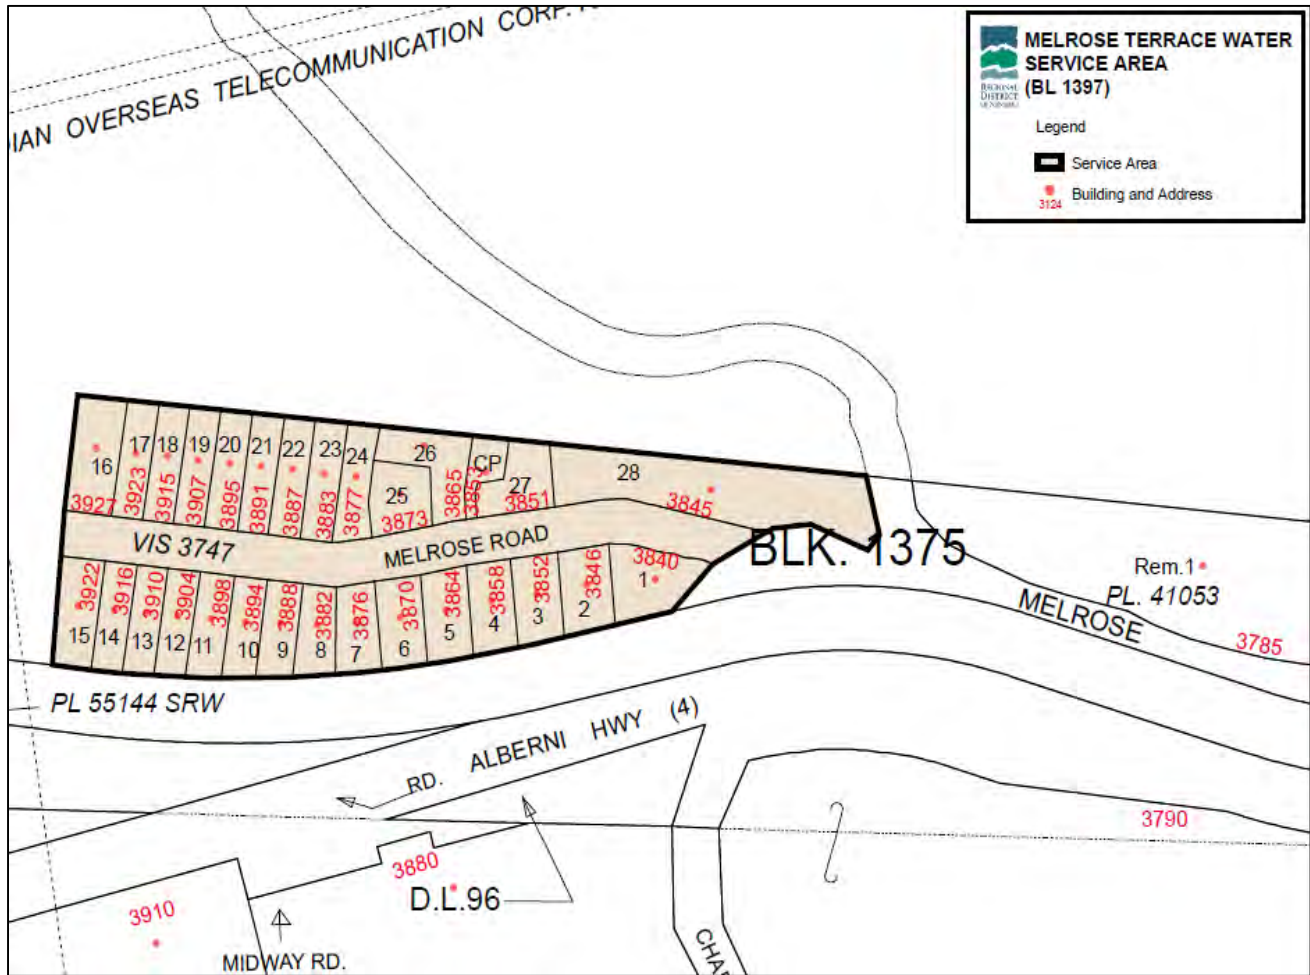
MELROSE  
WATER SERVICE AREA

**MAP OF MELROSE  
WATER SERVICE AREA**
