## Level 1 & 2 Environmental Site Assessment for the Moorecroft Camp Property, Nanoose Bay

Prepared by:  
Joe Materi, R.P.Bio.  
January 17<sup>th</sup>, 2011

Prepared for:  
Regional District of Nanaimo - Recreation & Parks  
Oceanside Place  
830 West Island Highway  
Parksville, B.C. V9P 2X4

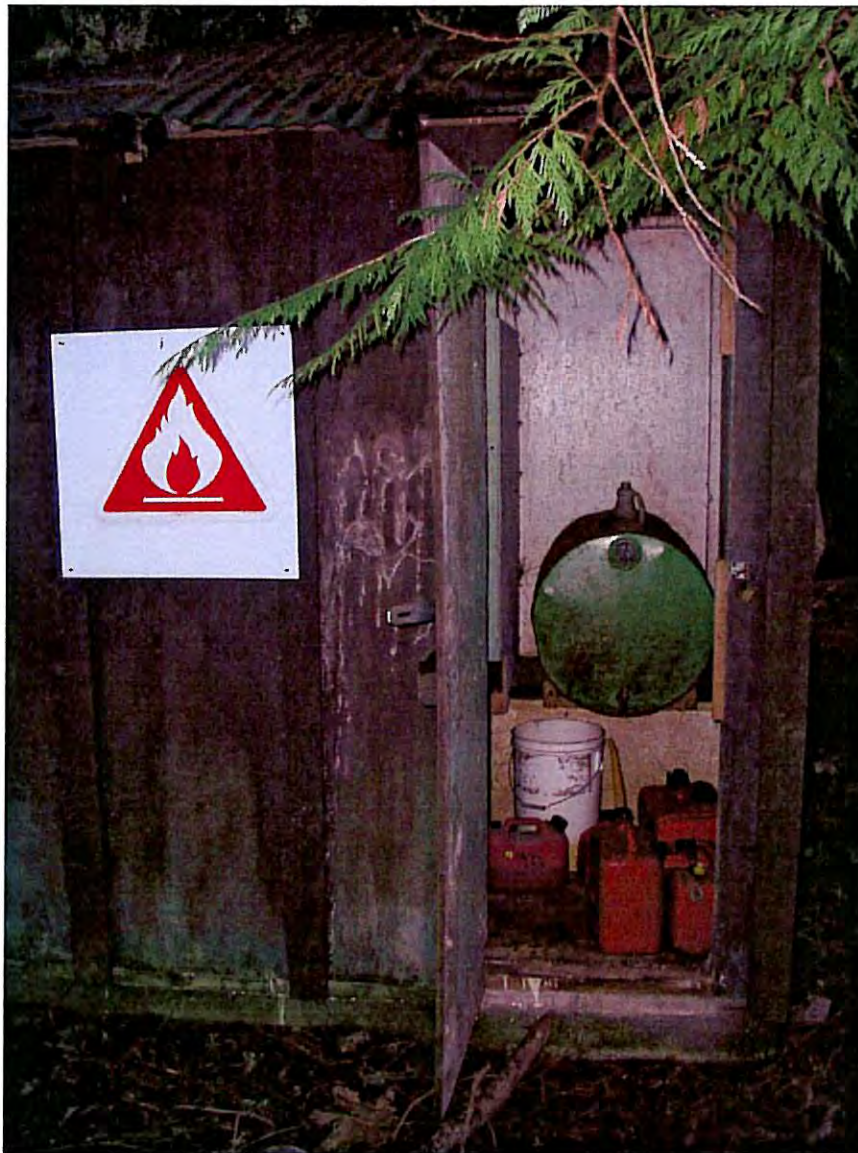
During the inspection, no large areas of stained soil or distressed vegetation were detected near areas associated with the storage of paints, chemicals, or hydrocarbons. Areas inspected included the six above-ground fuel storage tanks, the flammable liquids storage shed (Fig. 4), the wood shed/maintenance building, and the boat house. No unusual odours were detected in the above areas.

**Figure 4. No large areas of stained soil or distressed vegetation were seen around the flammable liquids storage shed, located between Splash 1 and Cabin 2.**

While a basic level of site management has prevented serious environmental degradation of the site, there is nevertheless one area of concern. Soil sample results from the flammable liquids storage shed found no detectable volatile hydrocarbons, but it did reveal elevated levels of the gross parameter Oil and Grease (O&G).

Subsequent to the removal of the flammable liquids storage shed, it is recommended that on-site bioremediation be carried out on underlying soils. Bioremediation has been employed as a cost-effective technique for cleaning hydrocarbon contaminated soils since the early 1990's. It takes advantage of native soil microbes that have adapted to using hydrocarbons as a carbon source. Bioremediation is usually feasible at sites where there is enough space to construct a bioremediation cell and enough time to allow significant biodegradation of the contaminants to occur (Vance 1991). At Moorecroft Camp, there is abundant open space for the anticipated volume of material and, with RDN ownership of the site, adequate time (i.e. one or two summers).

It is recommended that a bioremediation cell measuring approximately 25 m<sup>2</sup> be constructed in a level area with good machinery access. The cell should be lined with heavy poly sheeting and have a 30 cm high berm of clean material formed around its perimeter. The bottom of the cell should include an array of PVC drain pipes exposed to the open air at one end, to ensure the lower layers of the contaminated material are well-oxygenated. Heavy equipment could be used to excavate the material from the contamination plume and load it into a dump truck. The dump truck would transport the contaminated material to the remediation cell. Once in the cell, the material could be hand-raked to an even thickness of between 30 cm and 50 cm.

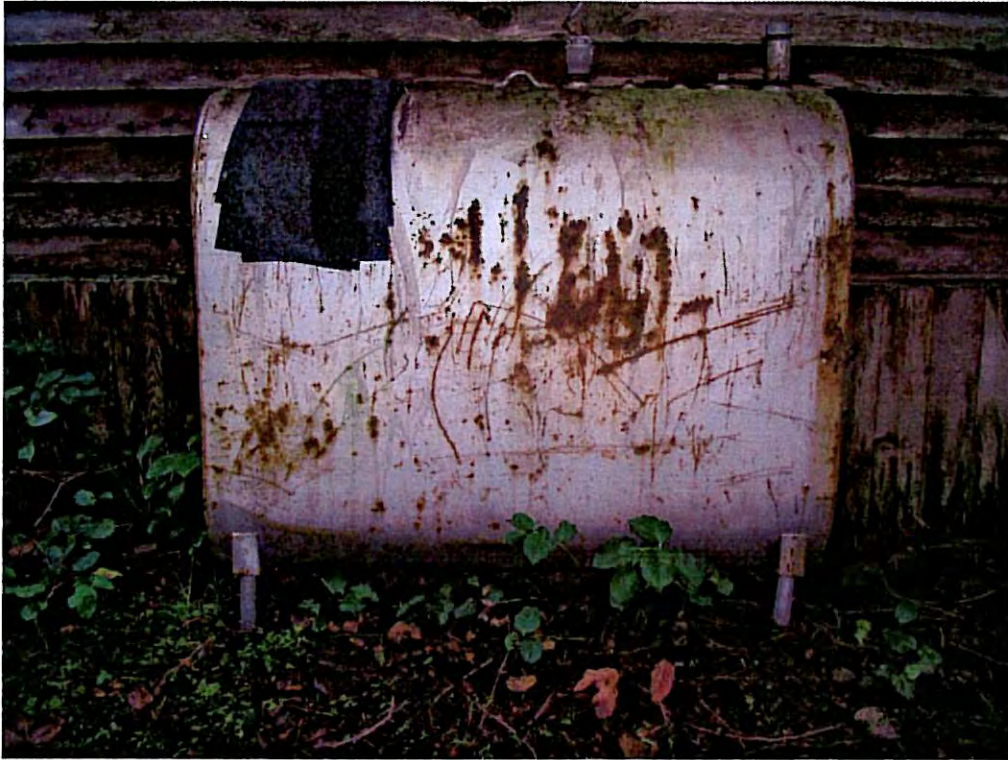
Almost all of the furnace oil storage tanks have some light surface rust on their exteriors, but only the tanks for Fern Cottage and Kennedy Lodge had flaking paint on their exteriors (Fig. 5). The large furnace oil storage tank for Stringer Hall, likely the oldest tank on the property, was assessed as being in good condition. Paint storage at the back of the wood shed/maintenance building appeared neat and tidy, with no stains observed on the shop floor (Fig. 6).

**Figure 5. Flaking paint was noted on the furnace oil tank for Fern Cottage.**

Based on the RDN's building Condition Report for Moorecroft Camp, it is likely that a number of the existing structures will be removed from the site. Buildings that might be torn down include several where hydrocarbon-based products were stored, namely: the flammable liquid storage shed, Splash 1, Fern Cottage, and Kennedy Lodge. Although none of the existing furnace oil tanks at the site are leaking, it is recommended that any heated buildings retained on the site be converted to systems representing a lower risk to the environment (e.g. electrical, propane, solar).

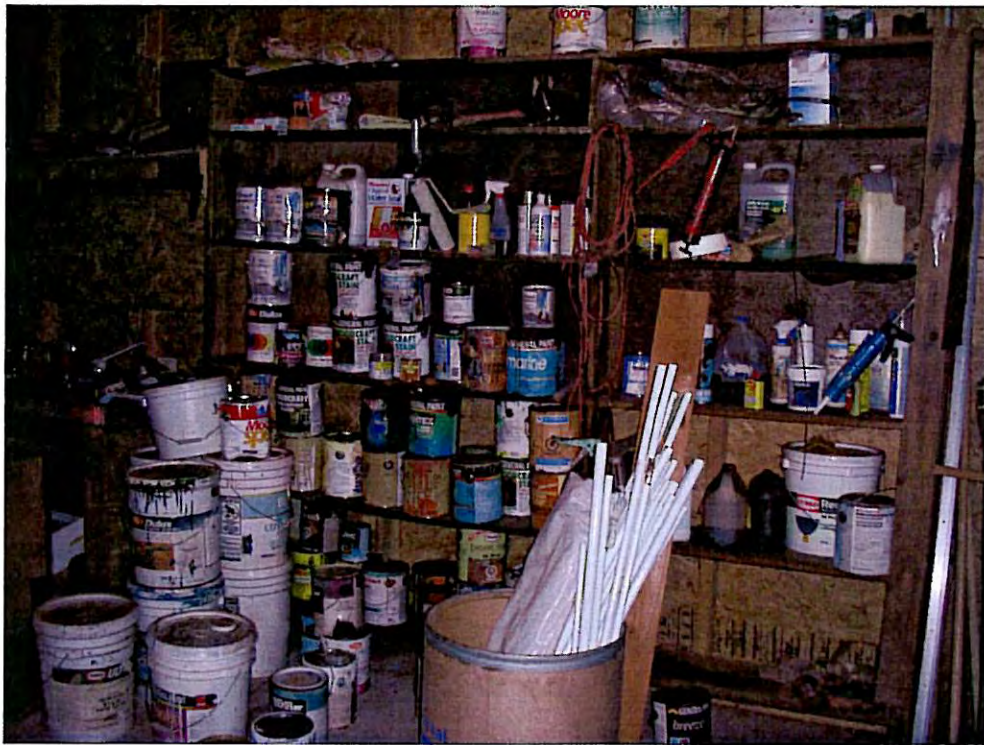
**Figure 6. No stains or questionable storage was observed within the paint storage area in the rear of the maintenance shed.**

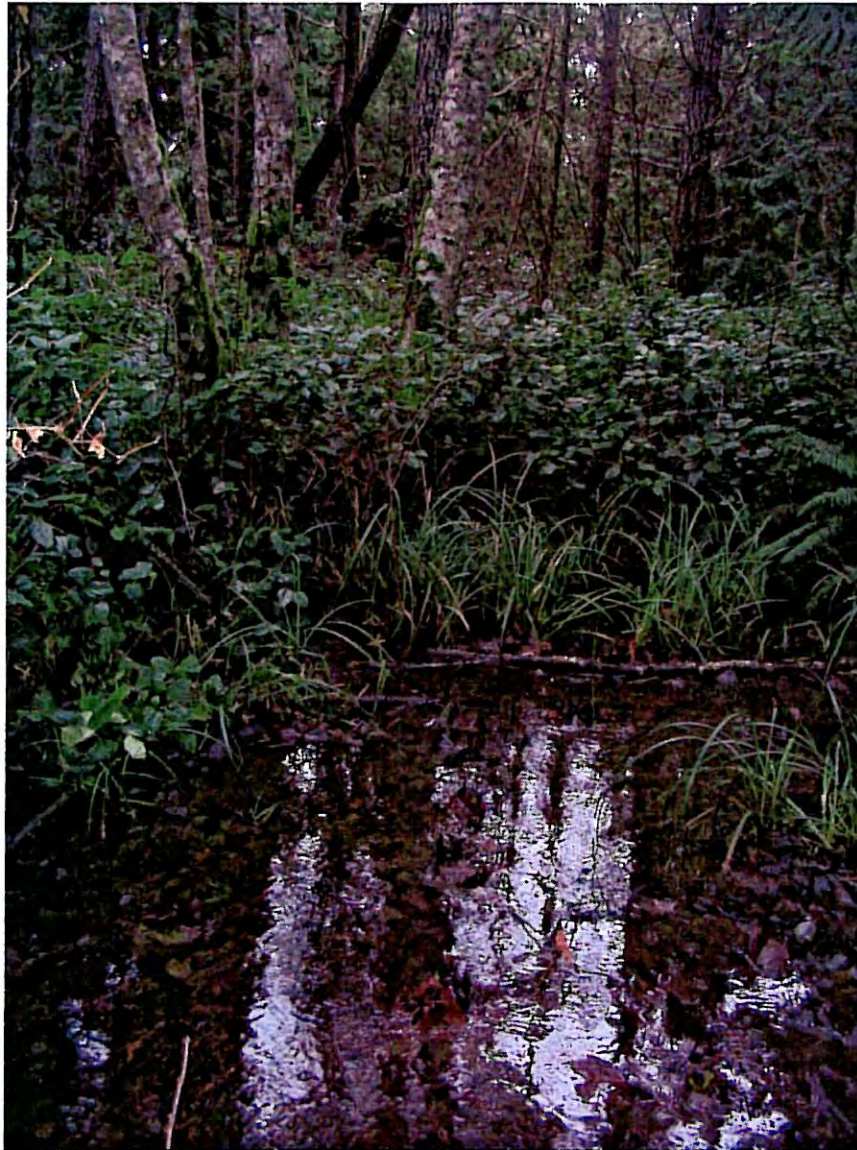
**Figure 7. Water quality appeared good in the small creek flowing from Skipsey Lake. The latter supported breeding by pollution-sensitive amphibians in 2007.**

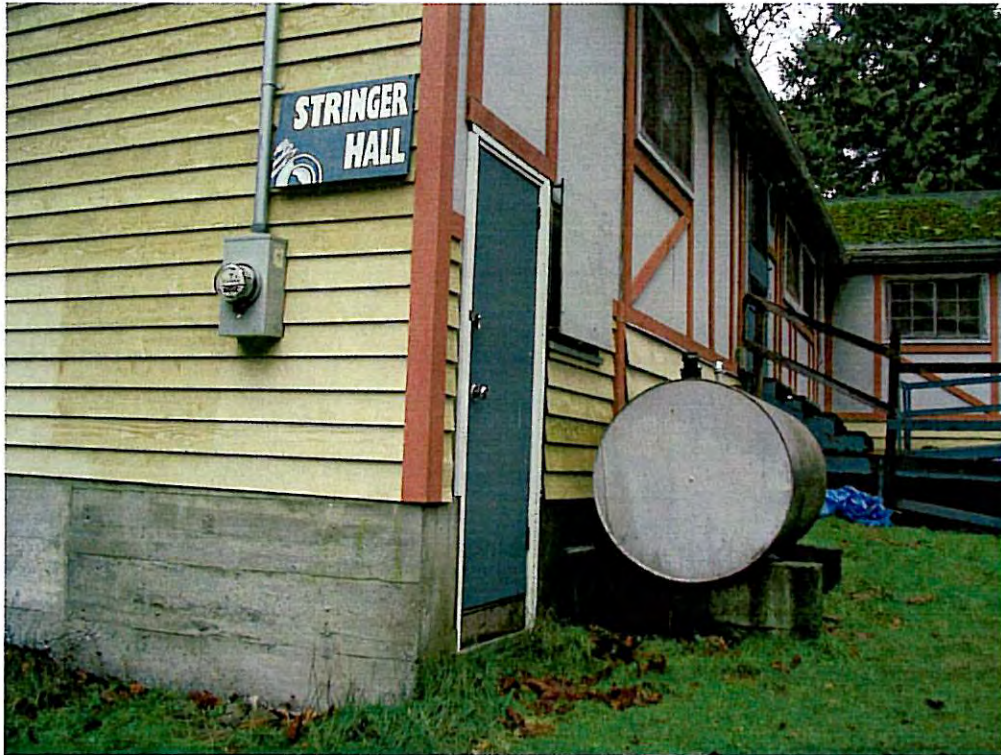
1. Despite its age, the furnace oil tank by Stringer Hall is in good condition.

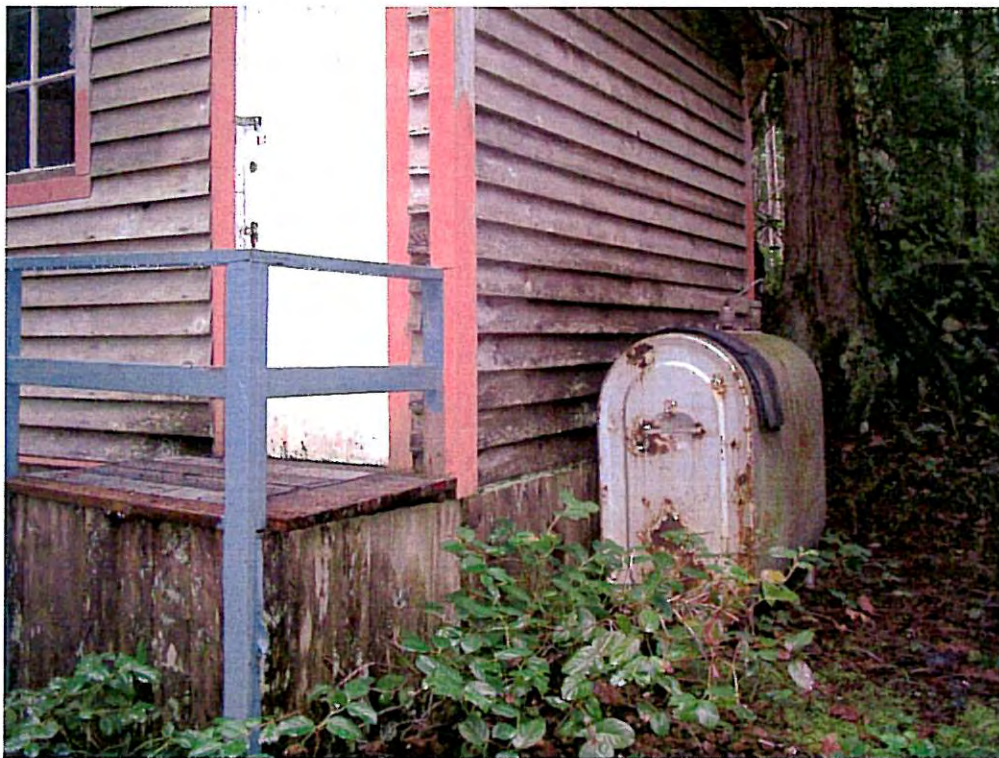
2. Fern Cottage with typical older 275 gallon furnace oil tank.

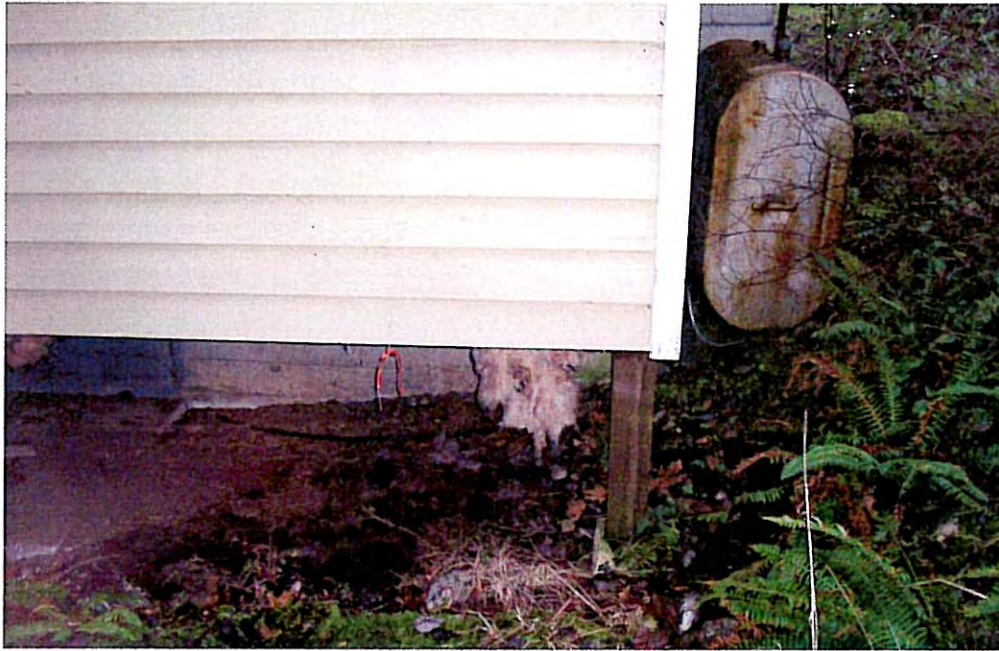
3. Heating oil tank located behind Caretaker's Residence.

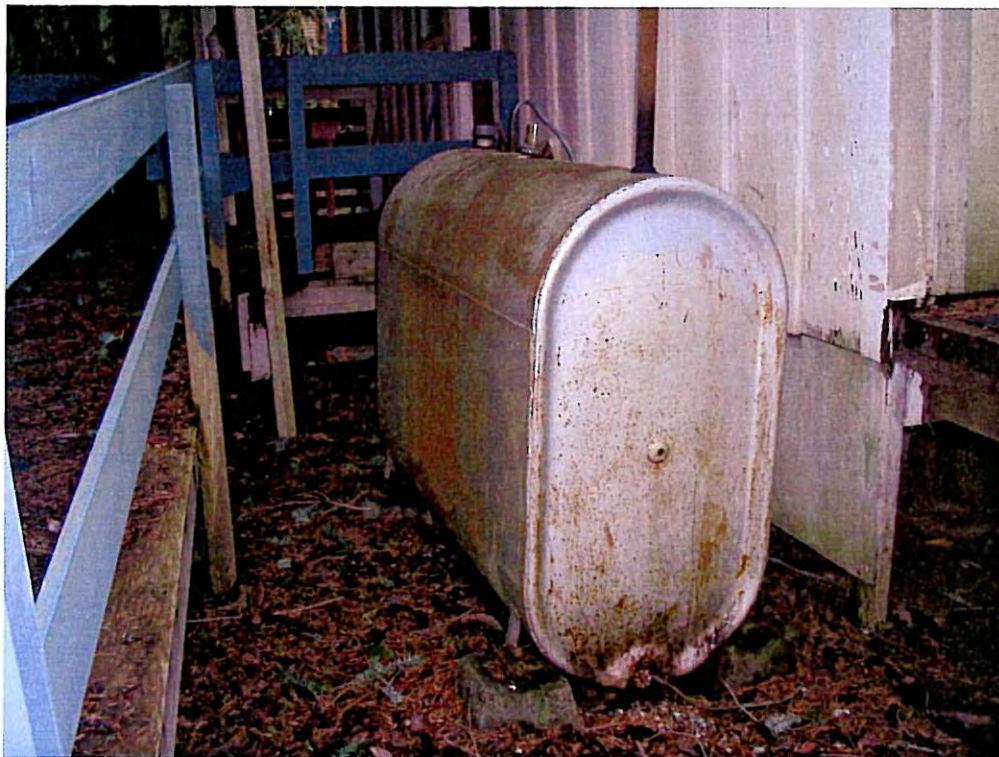
4. Heating oil tank on east side of Splash 1 building.

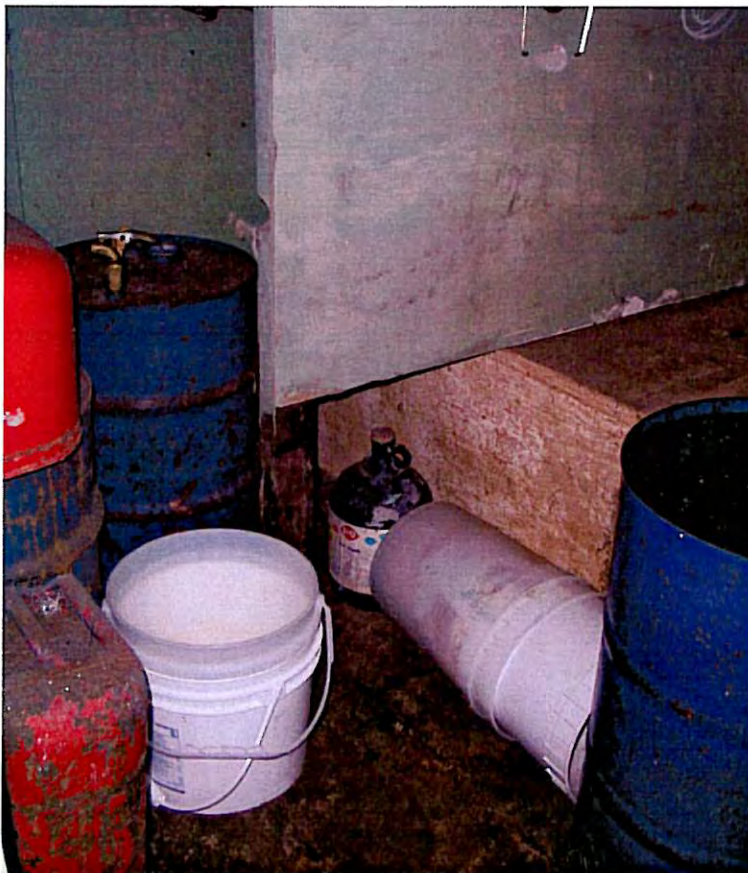
6. Interior view of flammable liquids storage shed.

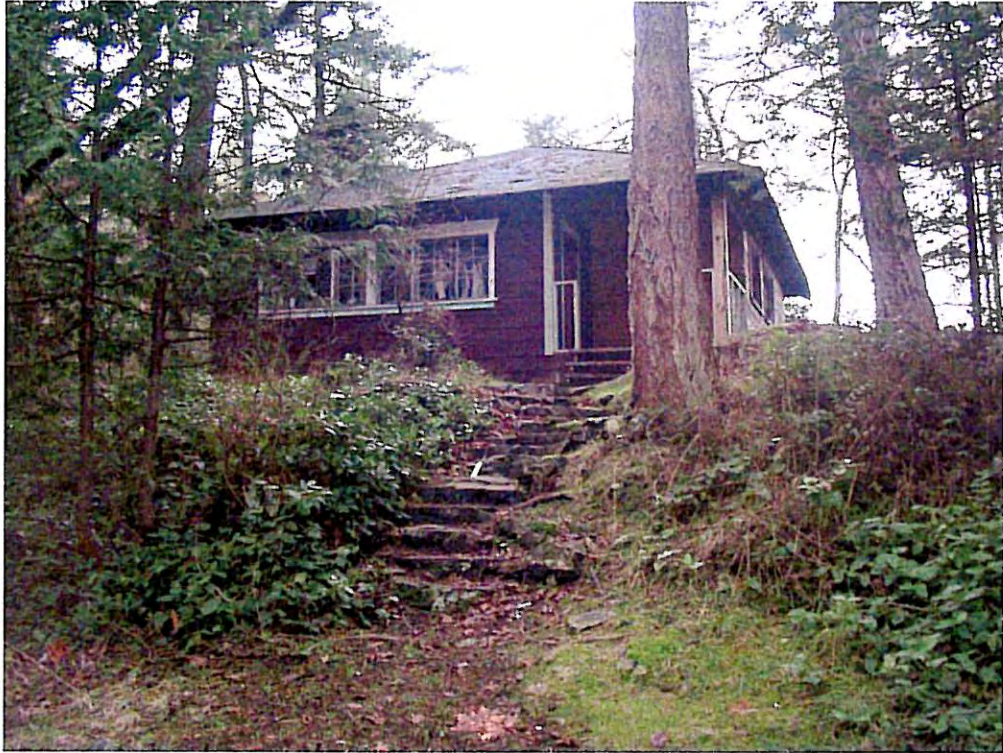
A fair amount of trash was observed in and around the abandoned craft hut. Most of it consisted of glass and wood. No sign of rusted metal barrels or abandoned refrigerators was detected outside this building or elsewhere across the site.

9. West entrance to abandoned Craft Hut building.
