Regional District of Nanaimo

2017 Biosolids Management Summary

February 2018

SYLVIS DOCUMENT #1148-18

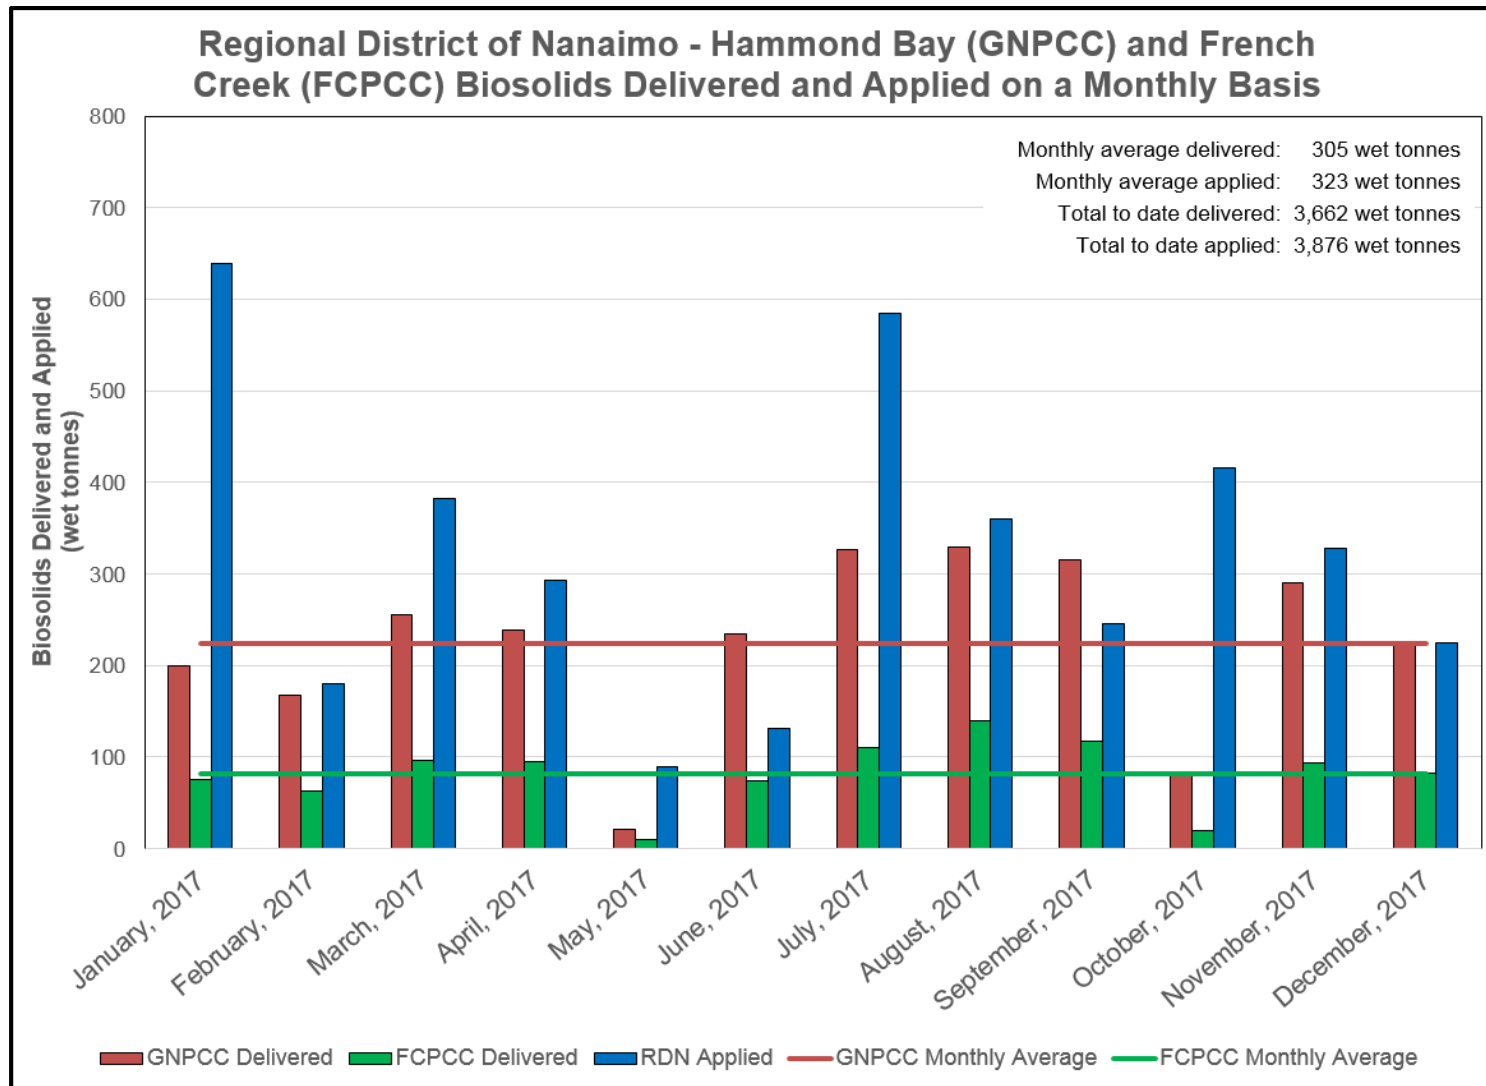
Figure 1: Tonnage of Regional District of Nanaimo dewatered biosolids managed at the TimberWest Properties by month in 2017.

In 2017, 3,662 wt of RDN biosolids (976 wt from FCPC; 2,686 wt from GNPCC) were transported by DBL Disposal to the TimberWest Properties (Table 2 and Photograph 1). Monthly tonnage delivered in 2017 is graphically summarized in Figure 1.

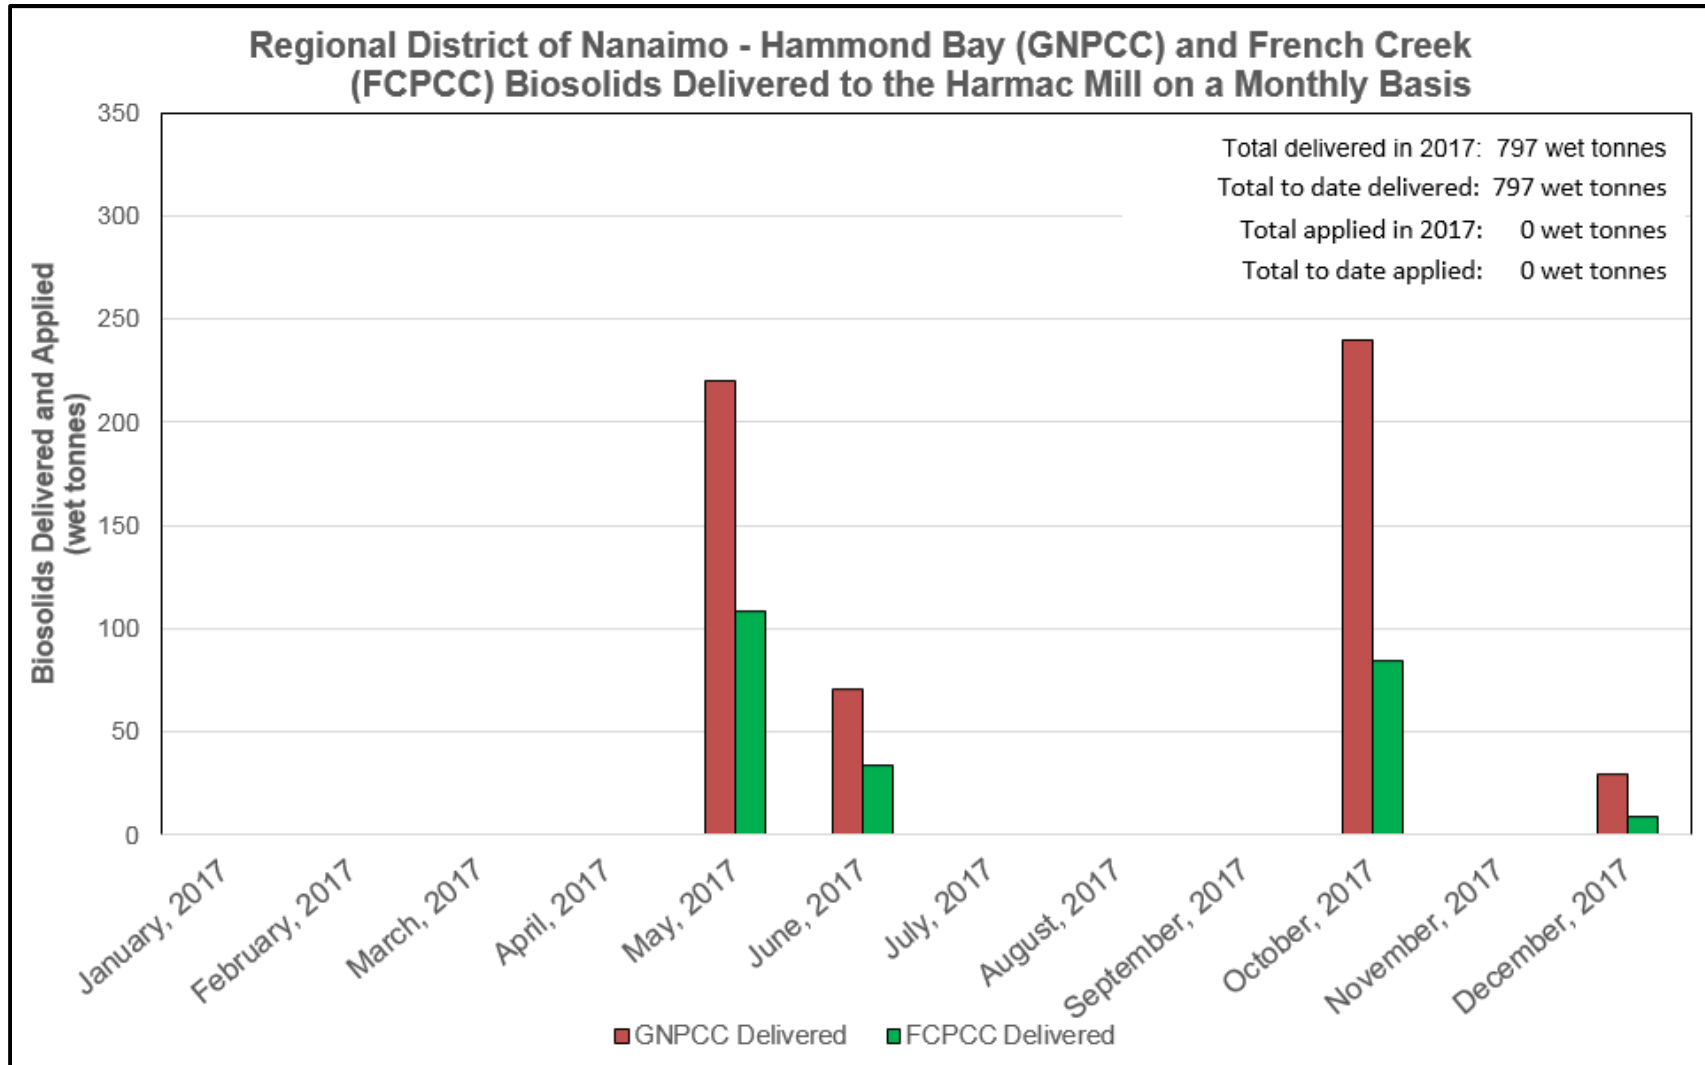
Figure 2: Tonnage of Regional District of Nanaimo dewatered biosolids managed at the Harmac Mill by month in 2017.

In 2017, 797 wt of RDN biosolids (236 wt from FCPC; 561 wt from GNPCC) were transported by DBL Disposal to Harmac (Table 2). Monthly tonnage delivered in 2017 is graphically summarized in Figure 2.

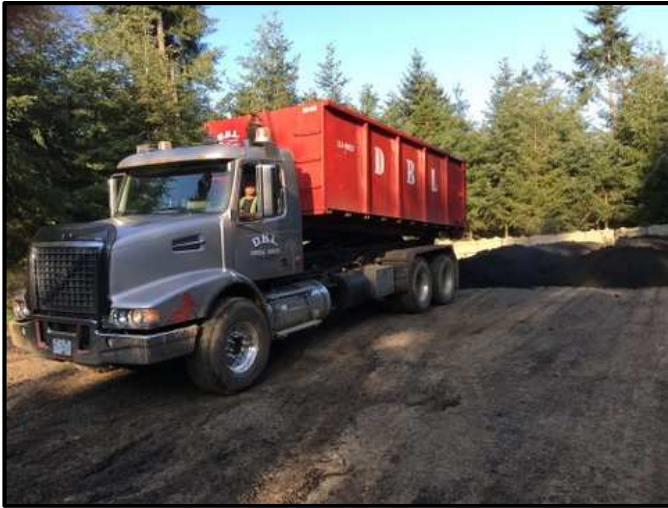
Photograph 1: RDN biosolids are delivered to the TimberWest Properties in 10-tonne bin trucks. (September 2016)

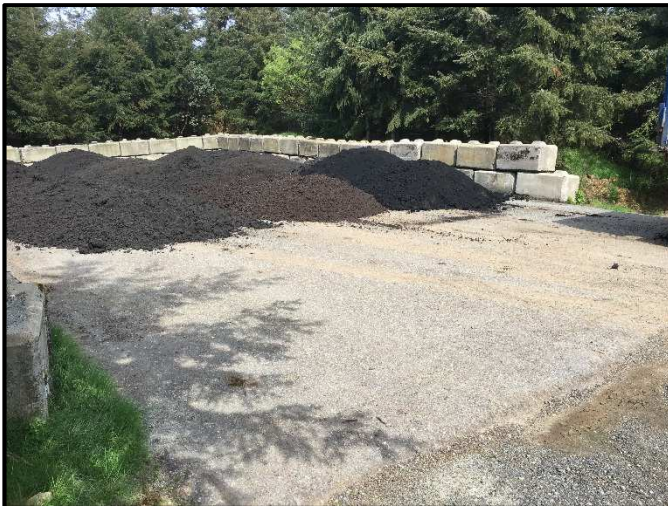
Photograph 2: Four biosolids stockpile facilities exist at the TimberWest Properties which consist of an asphalt pad and lock block barriers. (April, 2016).

The four storage facilities at the TimberWest Properties consist of an asphalt base with lock blocks delineating three sides of the facility (Photograph 2). Three of the facilities were utilized for biosolids stockpiling in 2017. Biosolids storage conformed to rainy season storage practices where biosolids are required by the *Organic Matter Recycling Regulation (OMRR)* to be covered from October 1st to March 31st of every year.

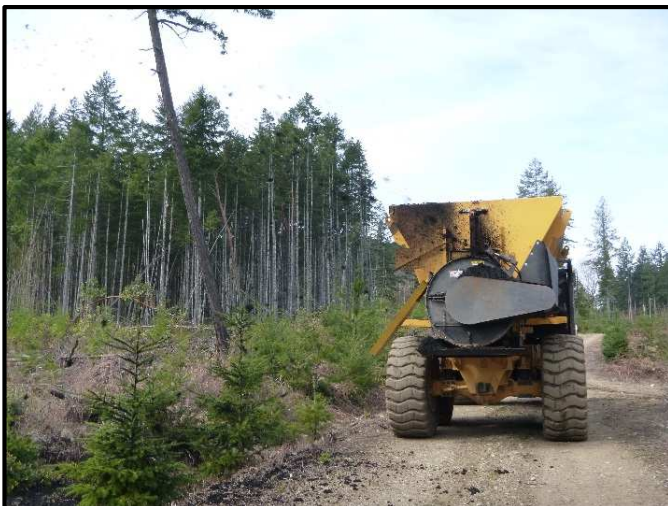
Photograph 3: Biosolids are applied from the roadway using customized SYLVIS heavy equipment which can apply 30 m into the forest. (March, 2014)

Biosolids was land-applied using a side-discharge spreader equipped with a hydraulic fan which propels the biosolids up to 30 m into forest stands (Photograph 3). All biosolids applications adhered to a 30-m setback distance from permanent water features and identified ephemeral water features. Biosolids applications were completed weekly or bi-weekly throughout 2017 except during periods of extreme weather (i.e., snowfall, heavy rainfall) or when ground was snow-covered: land application operations were suspended during these times.
