**REGIONAL DISTRICT OF NANAIMO
ELECTORAL AREA 'G' PARKS AND OPEN SPACE ADVISORY COMMITTEE
AGENDA**

BUILDING CONDITION ASSESSMENT REPORT

Little Qualicum Hall Building,
1210 Centre Road, Qualicum Beach BC

Risk Control Survey

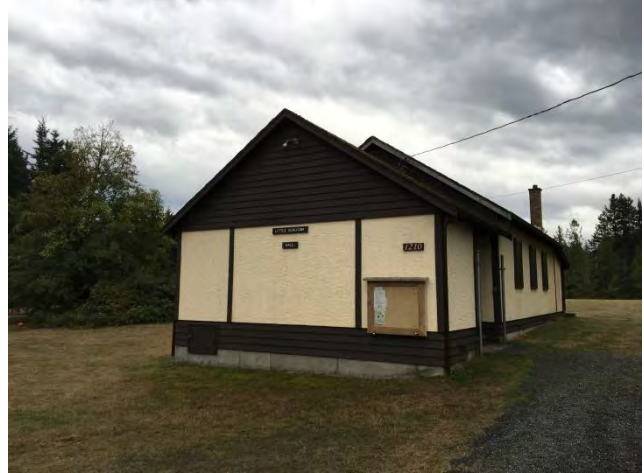
View from front of Hall

- Good/ Fair

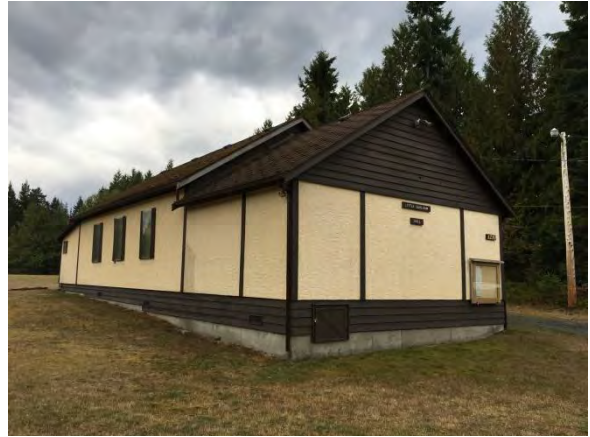
View from front of Hall

- Serviceable

The site drainage systems appear to be in serviceable condition, however, rainwater leaders are not directing water away from the foundations and the bathroom/kitchen area is framed within close proximity to the natural grade.

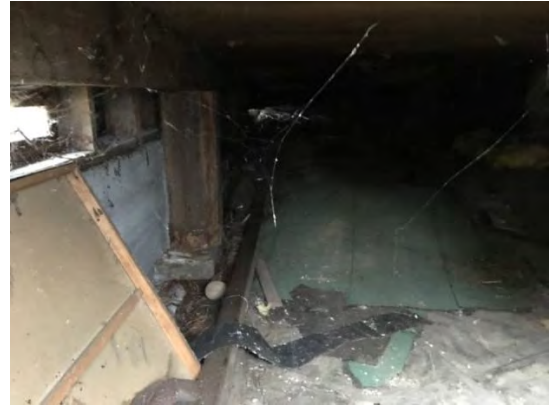
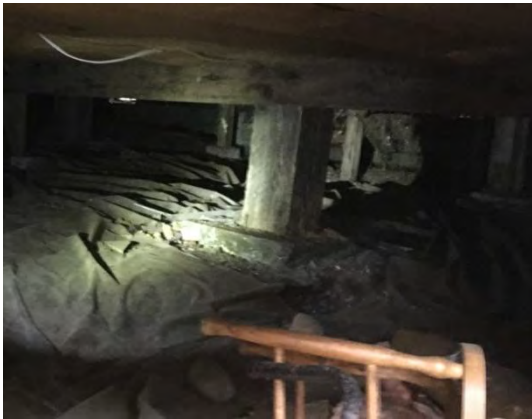
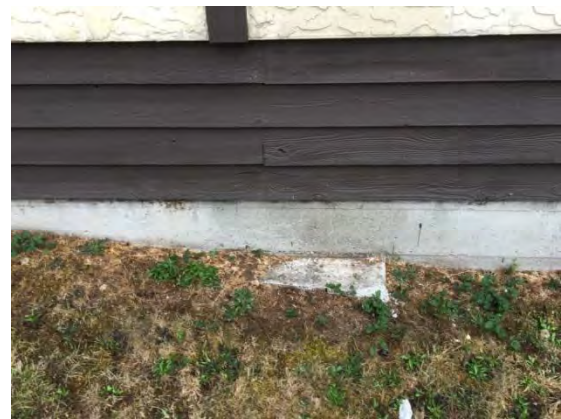
- Poor

View in crawl space

View of foundation

Where exposed, the primary structure was observed to be in fair to poor condition. There were some areas on the road side or front of the building where the structure was observed to be in fair condition for its age. However, at the rear of the building where the wood structure is located closer to grade the structure is observed to be in very poor condition.

The floor in the bathrooms has structurally failed. The area was not accessible due to the low clearance and debris in the crawlspace. It is our opinion that the washroom floor in the rear corner of the building should not be used by occupants in its current state. Any repairs should be directed by a Professional Engineer to determine the extent of deterioration and appropriate

repairs as the floor system does not appear to be adequately sized for the intended loads.

It was observed onsite, that it may be possible to repair or renovate the main hall structure however, the rear portion where the kitchen and washrooms are located are likely required to be rebuilt due to significant settlement and signs of deterioration.

Concrete foundations were found to be in good to fair condition. However, the crawl space is not heated and the foundations do not have adequate frost protection.

- The wood structure is in need of repairs to the front main hall portion and complete replacement in the rear kitchen and washroom portion. It will be required to redesign, repair and replace the wood structure, dispose of waste and add a new secondary exit at the rear. The bathroom area floor is deteriorated and may require structural joists to be replaced. Demolition of the floor area and a review of the floor framing required prior to reinstatement of any sheathing.

- Remove existing masonry chimney as this is a hazard during a seismic event.
- Double up all joists in the floor system and provide frost cover to the foundations, provide a ground seal to help control moisture.

- Anchorage of existing walls to foundations, improve connections of floor beams to posts, improve connection of walls to roof diaphragm for seismic stability.

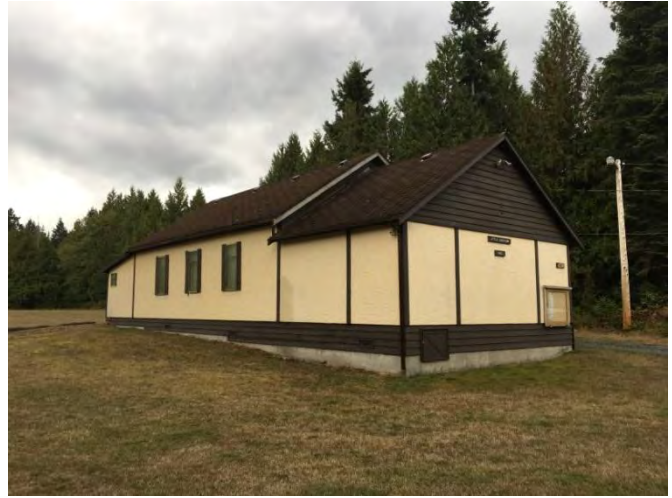
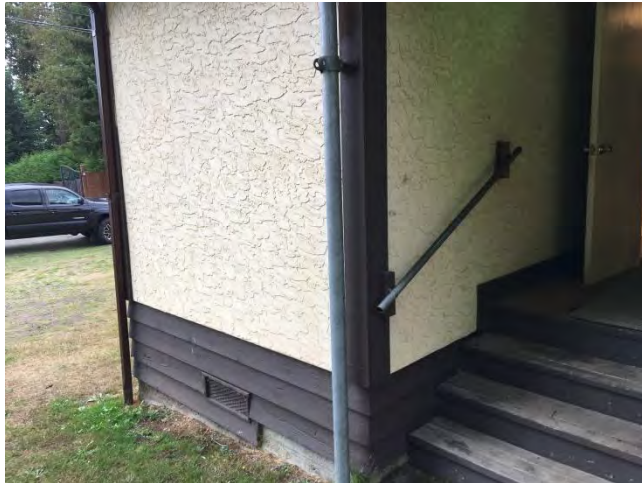
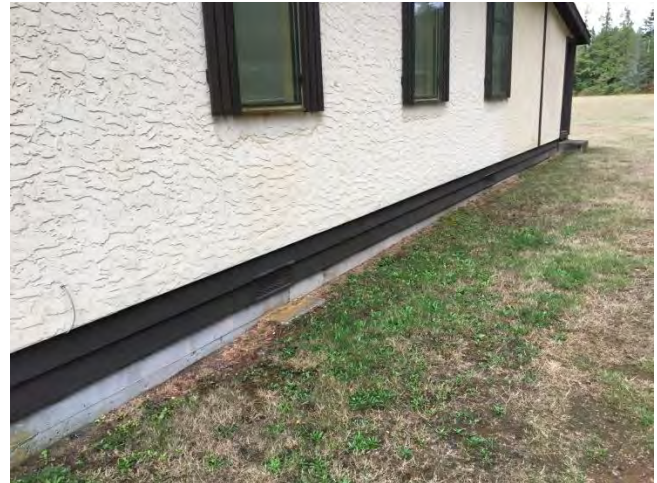
- Poor

View from front of Hall

View of handrail at entry stair

View of side of Hall

Generally, the stucco is in fair to poor condition, and nearing the end of its service life. The wood trim and fascias were observed to be in poor condition and appear due for replacement. Stucco Cladding can be an extremely durable exterior wall assembly provided that its performance characteristics are understood. The overall continued performance of the stucco clad walls will depend on periodic review and, if necessary, repair of the cracks and joints.

- The building currently has no handicap accessibility. A handicap ramp will need to be added to the new exit at the rear of the building and the front entry stairs and handrails will need to be replaced. The building is in need of a new handicap accessible washroom.

- The roofing and gutters are in need of replacement. Our observations indicate there is OSB sheathing on the roof that is in serviceable condition.
- The stucco and wood trims are in need of replacement and would be required to be replaced with a rainscreen cladding assembly.

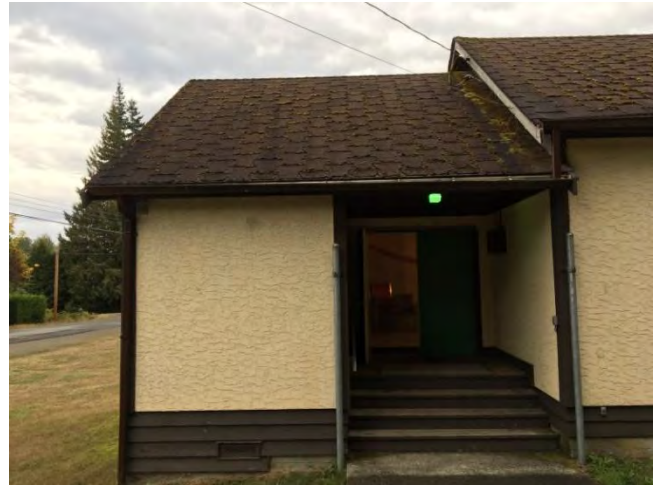
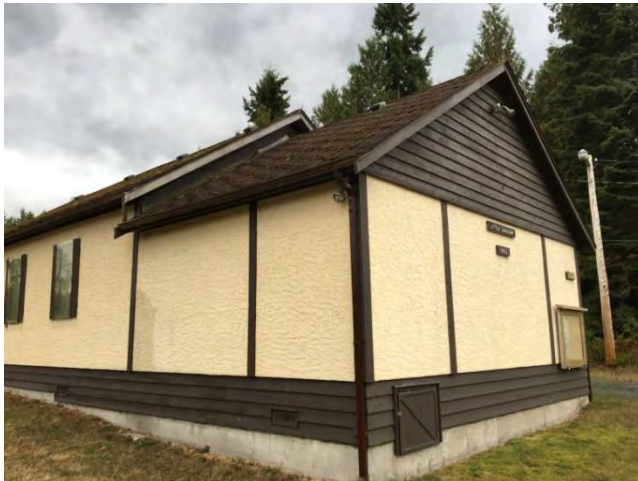
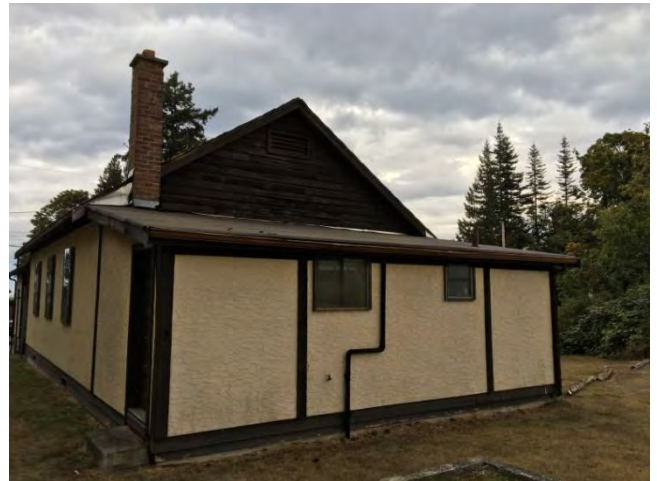
- Poor

View of roof over entry

View from front of Hall

View of roof over rear of Hall

The roofing consists of asphalt shingles over the main hall and asphalt roll roofing over the rear kitchen and washrooms. The soffits are painted, exposed wood rafters and plywood. The gutter over the front entrance is damaged and does not direct water to the rainwater leader. The rainwater leaders do not direct water away from the building foundation.

The roofing is expired and in need of replacement, the soffits are in need of repairs and repainting. The gutters and rainwater leaders need repair/replacement. Furthermore, we recommend removing or replacing the chimney with a metal one as the current one could be a significant hazard during a seismic event.

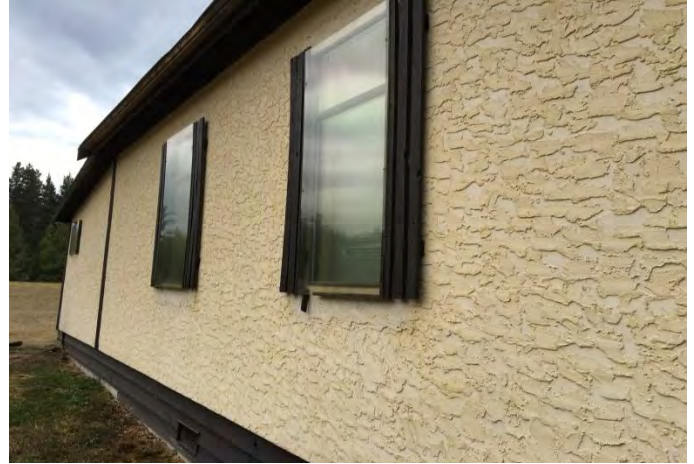
View of side windows

- Fair

The windows are double pane with non-thermally broken aluminum frames which were installed in circa 1995.

Most of the windows have an exterior plexi glass frame/covering, providing protection which has prevented severe weathering of the windows. While the frames and glazing continue to function as intended they are considered to have a very poor thermal performance with a high level of heat loss during the heating season.

Given the age of these assemblies, it is recommended that consideration be given to the replacement of the existing windows with assemblies that are compliant with current North American Fenestration Standard (NAFS) requirements with respect to thermal performance and air and water penetration requirements. It is advised that the replacement windows be installed in accordance with Best Practices for Window and Door Replacement in Wood-Frame Buildings, publication.

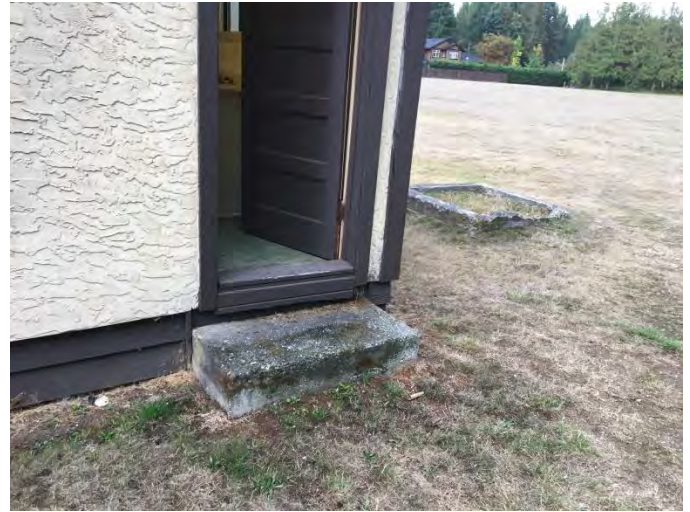
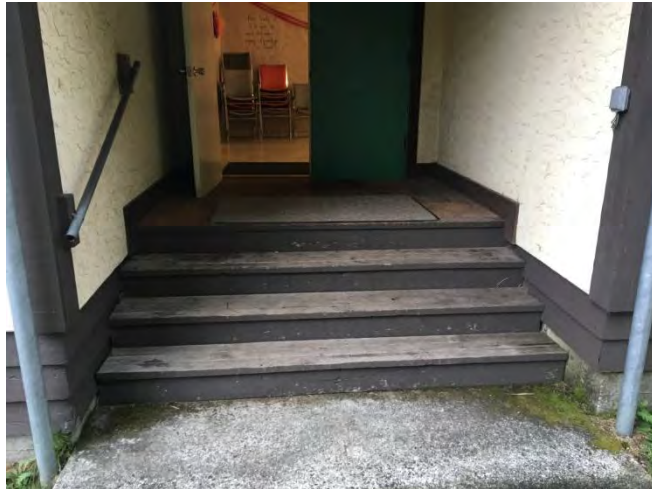
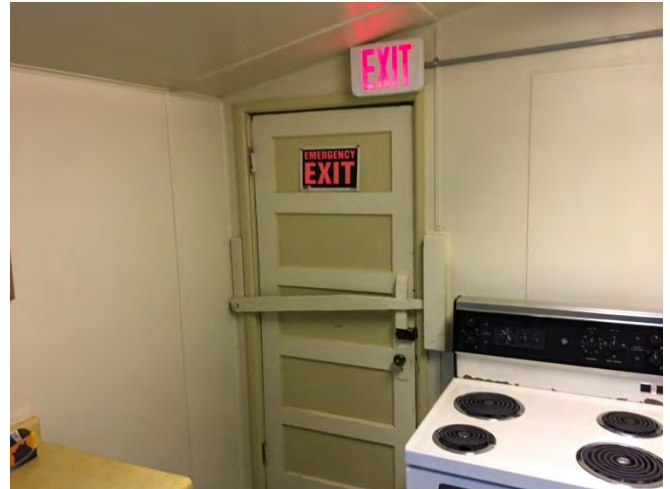
- Poor

View of rear kitchen door

View of main entry door and stair

View of kitchen door

All doors, frames and hardware are in poor condition and are in need of replacement.

- The aluminum, non-thermally broken windows and exterior and interior doors have reached the end of their economic service life and will require replacement. We recommend that the Owners consider a replacement program.

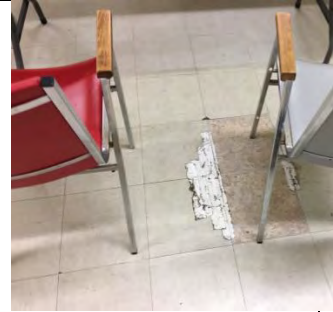
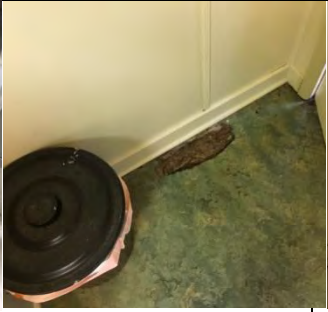
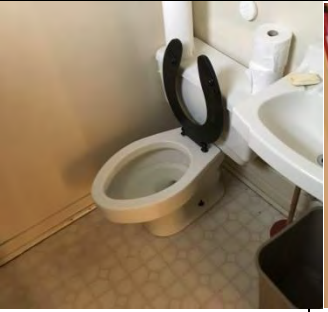
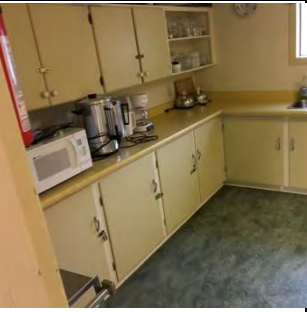
Hall-Flooring	Kitchen Flooring	Bathroom Flooring	Kitchen	
<u>Asset Description</u>				
Interior finishes consist of vinyl tile flooring throughout the Hall. The walls and ceilings are all generally painted wood paneling.				
<u>Observations / Comments</u>				
Interior finishes are in poor condition and in need of replacement. The vinyl tile flooring in the main hall contains asbestos, and the paint is lead based according to the Hazardous Materials Report completed by Lewkowich Engineering and Associates dated March 29, 2017.

- The flooring is in need of replacement and abatement is required of the existing floor coverings.

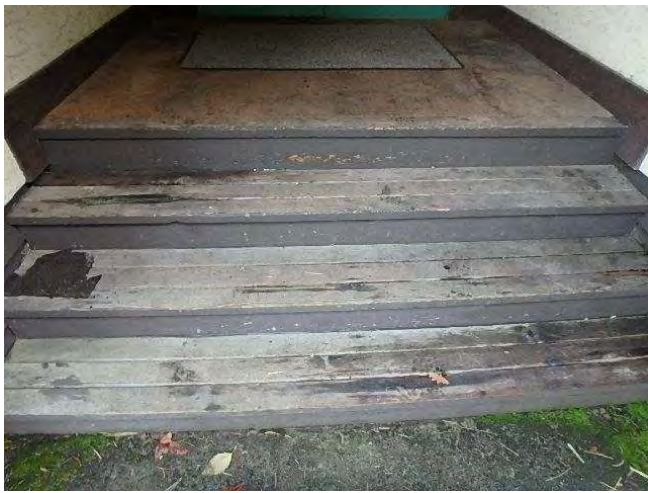
2.2 RECOMMENDATION

Hazard Description The building's exterior stairs lack a slip resistant surface finish.	
	Cause and Effect This creates an unsafe condition and an unnecessary liability hazard.	
Hazard Location Little Qualicum Hall		
RECOMMENDATION REFERENCE ID	2017-02	
RECOMMENDATION SUB-TYPE	<input checked="" type="checkbox"/> SLIP, TRIP AND FALL	
RECOMMENDATION	All exterior stairs should be provided with a slip resistant finish such as adhesive slip resistant strips to prevent slipping and falling accidents.	
ADEQUACY OF EXISTING CONTROLS	<input type="checkbox"/> LOW <input type="checkbox"/> HIGH	<input checked="" type="checkbox"/> MEDIUM
CONSEQUENCE RATING	<input type="checkbox"/> 1 <input type="checkbox"/> 3 <input type="checkbox"/> 5	<input checked="" type="checkbox"/> 2 <input type="checkbox"/> 4
LIKELIHOOD RATING	<input type="checkbox"/> 1 <input type="checkbox"/> 3 <input type="checkbox"/> 5	<input checked="" type="checkbox"/> 2 <input type="checkbox"/> 4

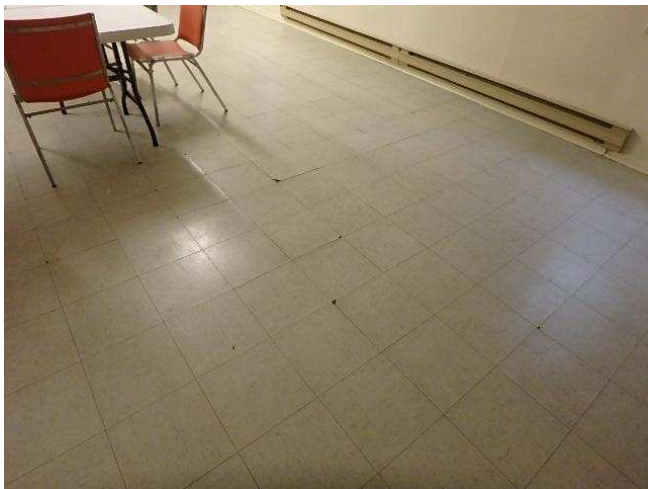
2.3 RECOMMENDATION

Hazard Description Our inspection revealed that the interior floor surface is damaged and uneven.	
	Cause and Effect The broken tiles are creating a potential tripping hazard.	
Hazard Location Little Qualicum Hall		
RECOMMENDATION REFERENCE ID	2017-03	
RECOMMENDATION SUB-TYPE	<input checked="" type="checkbox"/> SLIP, TRIP AND FALL	
RECOMMENDATION	To prevent injury, it is recommended that the tile surface be repaired.	
ADEQUACY OF EXISTING CONTROLS	<input type="checkbox"/> LOW <input type="checkbox"/> HIGH	<input checked="" type="checkbox"/> MEDIUM
CONSEQUENCE RATING	<input type="checkbox"/> 1 <input type="checkbox"/> 3 <input type="checkbox"/> 5	<input checked="" type="checkbox"/> 2 <input type="checkbox"/> 4
LIKELIHOOD RATING	<input type="checkbox"/> 1 <input type="checkbox"/> 3 <input type="checkbox"/> 5	<input checked="" type="checkbox"/> 2 <input type="checkbox"/> 4
RISK SCORE-LEVEL OF RISK	<input type="checkbox"/> 1-3 INSIGNIFICANT <input type="checkbox"/> 5-10 MEDIUM <input type="checkbox"/> 15-25 EXTREME	<input checked="" type="checkbox"/> 3-5 LOW <input type="checkbox"/> 10-15 HIGH

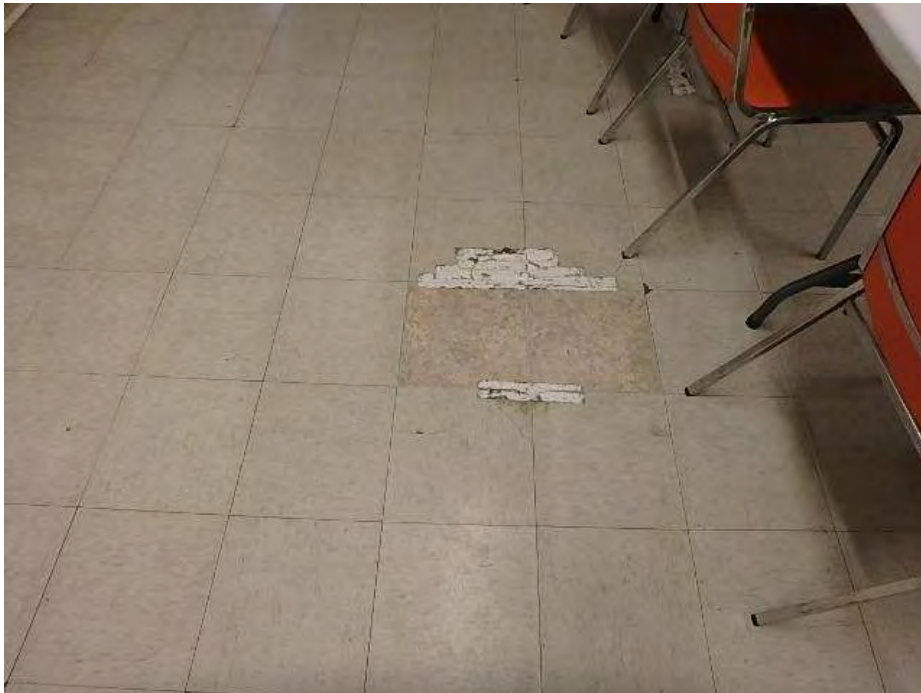
Uneven tiles (2017-03)

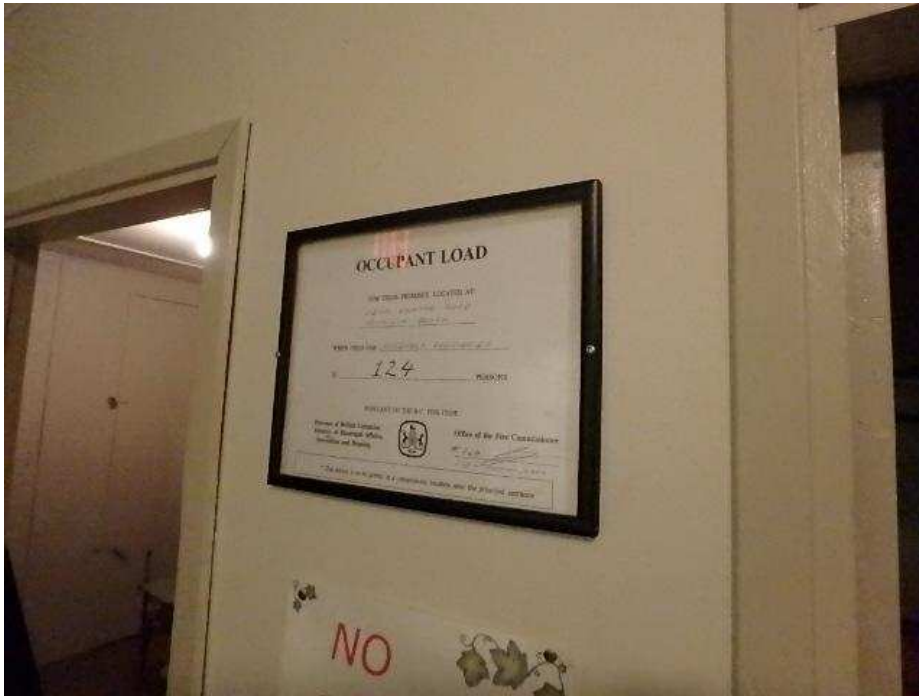
Posted occupancy load

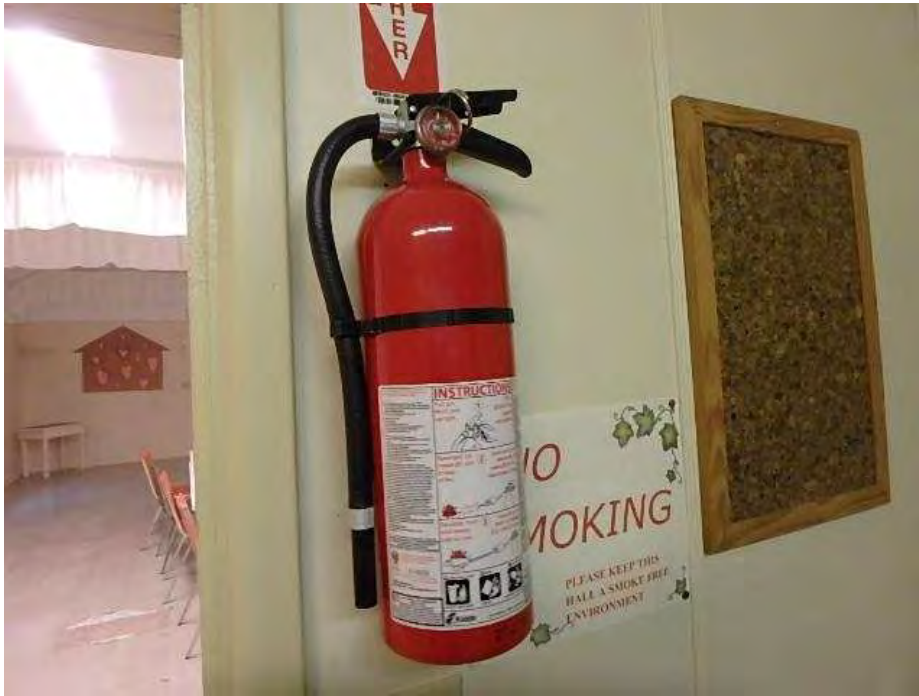
Extinguisher due for service
