The following annual report describes the Wall Beach Water Local Service Area and summarizes the water quality and production data from 2007. This report also includes a summary of inquiries and complaints, completed and proposed maintenance activities, the Emergency Response Plan, and the Cross Connection Control Program.

### 2. Wall Beach Water System

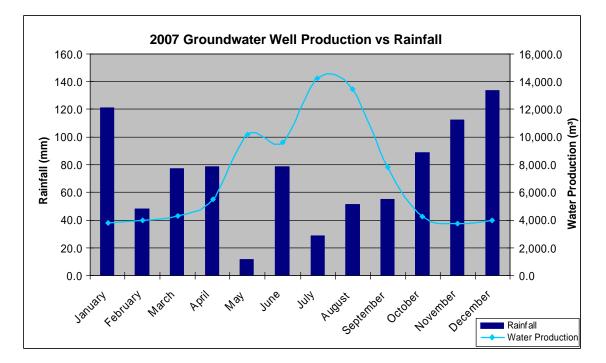
The 2007 monthly groundwater production for Wall Beach/Madrona is shown in the chart below. The number of Wall Beach water service connections represents only 14 of 317 total water connections in the Wall Beach/Madrona area. Groundwater production has been charted against rainfall data from the City of Parksville website to show how rainfall affects the amount of groundwater pumped.

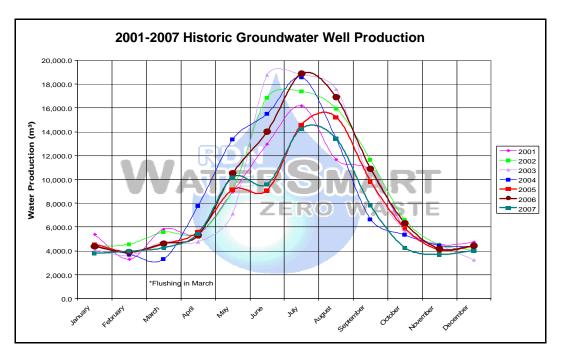
The monthly groundwater production for the Wall Beach/Madrona area for the past 7 years is shown in the chart below. Groundwater production in 2007 was typically lower than previous years.

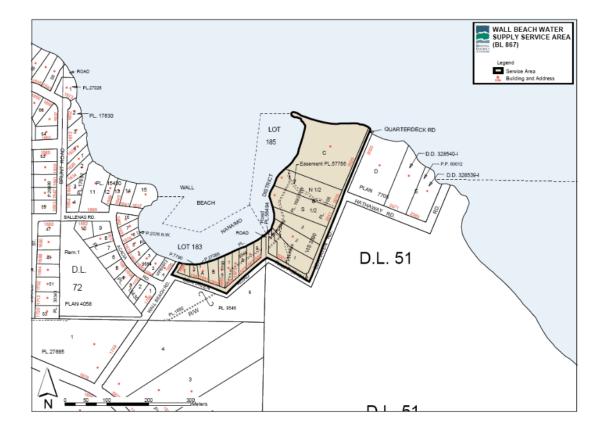
# WALL BEACH

The water distribution system in Wall Beach is comprised of 100mm and 150mm asbestosconcrete watermains, and 150mm PVC watermains. Fire hydrants are located throughout the system.
